Subject: INTERFERENCE BETWEEN TRUNK, REAR COMBINATION LAMPS AND/OR REAR BUMPER	Bulletin No: 09-028/04
	Last Issued: 8/26/2004

APPLICABLE MODEL(S)/VINS

2004 RX8 - VINs lower than JM1FE17**40113721

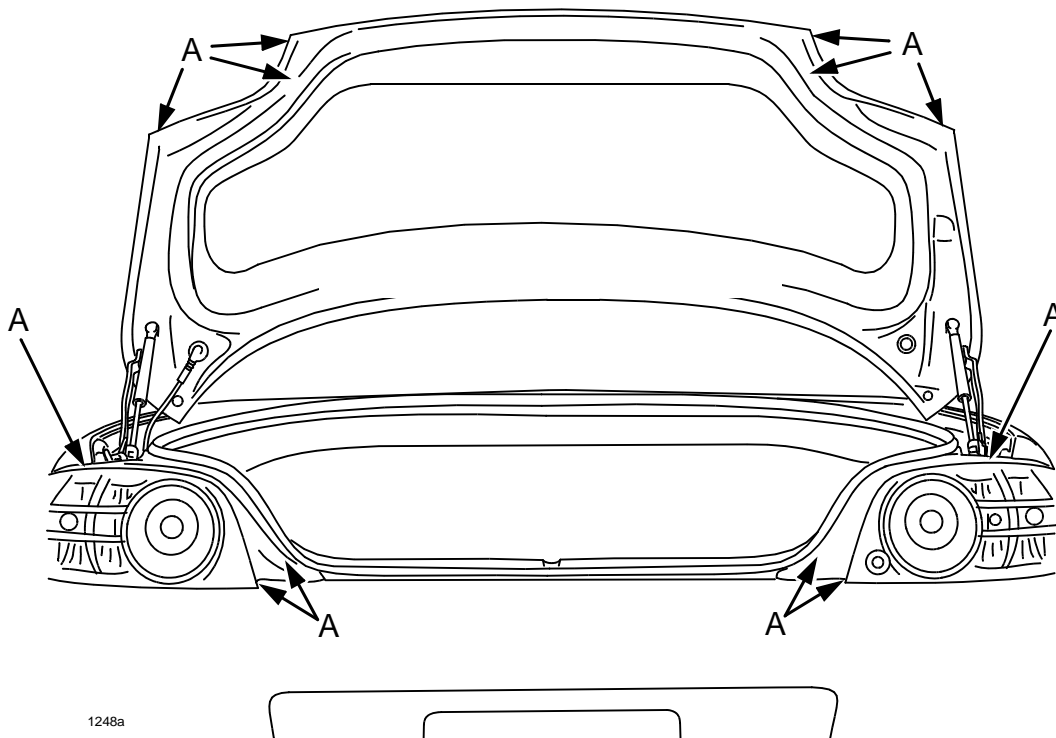
Some vehicles may exhibit damage on the left and right rear combination lights, trunk and/or rear bumper. This may be caused by interference between the trunk, rear combination lights and bumper.

CHECK FOR INTERFERENCE AT THESE POINTS - "A"

1. Verify customer concern. Check for damage caused by contact between trunk lid, rear combination lights, edge of trunk lid and/or rear bumper cover.
2. Repair contact damage as follows:
 - a. Use de-greaser or window cleaner to clean the damaged area.
 - b. Polish the damaged area and around the damaged area with a light buffing compound safe for clear coat.
 - c. Remove all compound residue using a soft cloth.
3. Apply protector film to the trunk lid inner panel as follows:
 - a. Use de-greaser to clean the area where protector film will be applied.
 - b. Place the protector film (without peeling off the backing sheet) by the edge of trunk lid as shown.
 - c. Peel off the lower portion of the backing sheet (1) and attach the protector film.
 - d. Peel off the remaining portion of the backing sheet (2) and attach the protector film.

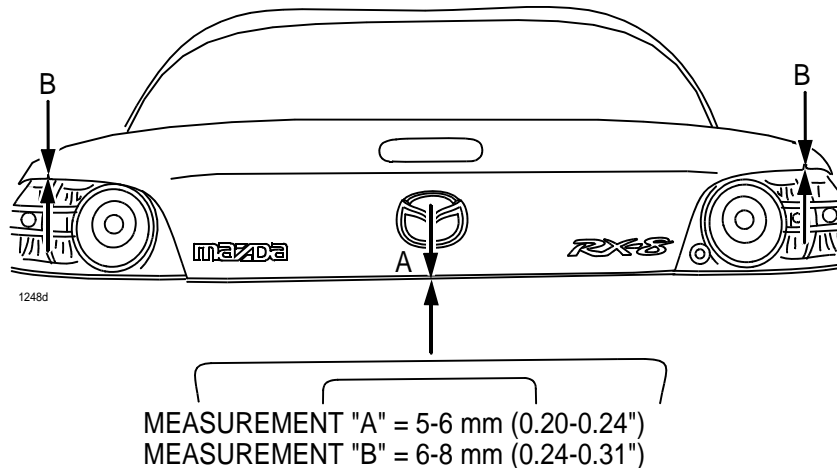
- Measurement **A** between the trunk lid and bumper:
5.0 - 6.0 mm (0.20 - 0.24 inch)
- Measurement **B** between the trunk lid corners and rear combination lights:
6.0 - 8.0 mm (0.24 - 0.31 inch)

5. Measure distance between trunk lid-to-rear combination light and trunk lid-to-rear bumper. If measurements are as follow, go to STEP 7. If measurements are not as follow, go to next step.

6. Adjust the trunk lid latch to ensure proper clearance.
- a. Remove the trunk end trim surrounding the trunk lid latch striker by unscrewing the hooks (vehicles with rear cargo net) or by removing the 4 push-pin fasteners (vehicles without rear cargo net) and pulling trunk end trim upward to release clips.
 - b. Loosen the 3-trunk lid latch striker bolts.
 - c. Adjust the trunk lid latch so the trunk lid-to-rear combination light and trunk lid-to-rear bumper clearances are as specified in STEP 5.
 - d. Tighten truck lid latch striker bolts.
7. Verify repair.
