Service Bulletin

INTERIOR TIRE HOUSE TRIM LIFTING OVER BOTH REAR WHEEL HOUSINGS

Bulletin No: 09-004/04

2004 RX-8 - Prior to VIN JM1FE17**40112425

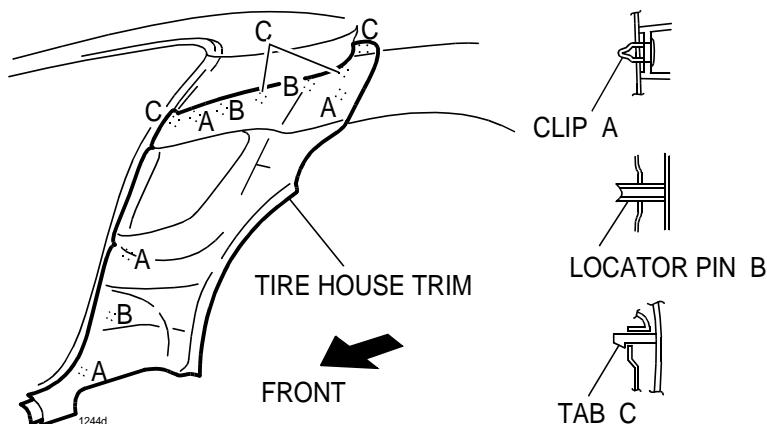
Interior tire house trim over both rear well housings may lift due to the position of a wiring harness and metal clip on the back side of the tire house trim. Use the procedure below to first reposition the interfering wiring harnesses on each side of the vehicle using the **modified** "T" shaped clip and then reinstall the tire house trim using a **redesigned** resin clip to replace the metal clip on both tire house trims.

- a. Firmly lift the front of the rear seat cushion upward to disengage retainers. Remove rear seat cushion by lifting front of seat cushion up to disengage rear hook.
- b. Remove 2 bolts at bottom of seat back, then remove the rear seat back by sliding upward and disengaging clips at top of seat back.
- c. Remove seat belt from seat back guide and remove seat back.
- d. Pull the outer edge of scuff plate upward to detach clips from the body and remove scuff plate.
- e. Partially peel back the seaming welt weather-strip.
- f. Pull the tire house trim outward and detach clips A and locator pins B.
- g. Detach tabs C and remove the tire house trim.
