Subject: LOW OIL LEVEL WARNING LIGHT COMES ON WHEN LEVEL IS NOT LOW	Bulletin No: 01-013/04
	Last Issued: 4/14/2004

2004 RX8 - VINS: JM1FE17* *40000000 to 40111043

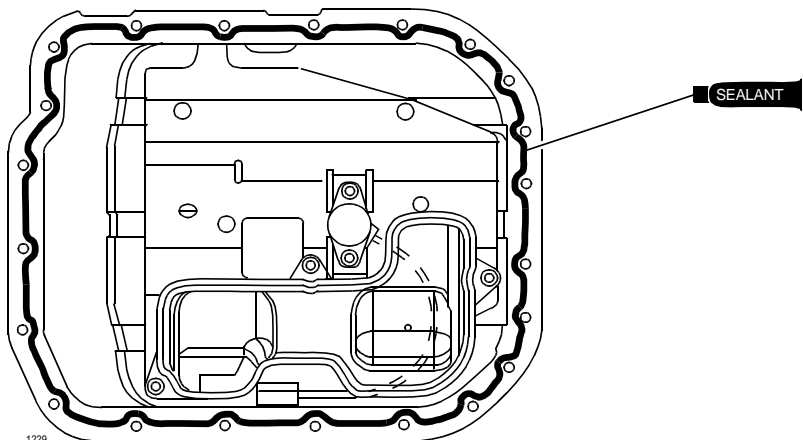
The low oil level warning light may come on while driving with engine speed 4500 to 4800 RPM and the oil level is within specifications (1/4 above L on the dipstick).

1. Remove the oil pan.
 - a. Disconnect the oil level sensor electrical connector from the side of the oil pan.
 - b. Remove the oil pan bolts (22-10mm)
 - c. Separate the oil pan from the engine
2. Install the new oil pan and level sensors assembly.
 - a. Clean all silicone sealant, oil and dirt from the engine.
 - b. Clean all silicone sealant from the oil pan bolts.
 - c. Apply a **2.5 to 6.5mm (0.10 to 0.26in)** bead of silicone sealant to the oil pan as shown.
 - d. Install the oil pan bolts and torque to **8.8 to 11.8Nm (77.9 to 104.4 inlb)**.

3. Connect the oil level sensor electrical connector to the side of the oil pan.
4. Fill the engine with oil.
5. Verify Repair.
