Service Bulletin Mazda North American Operations

Subject: MIL ON - P2070 SET	Bulletin No:	01-019/08
	Last Issued:	4/18/2008

2004-2007 RX-8 vehicles with VINs lower than JM1 FE**** ** 213322 (built before April 18, 2007)

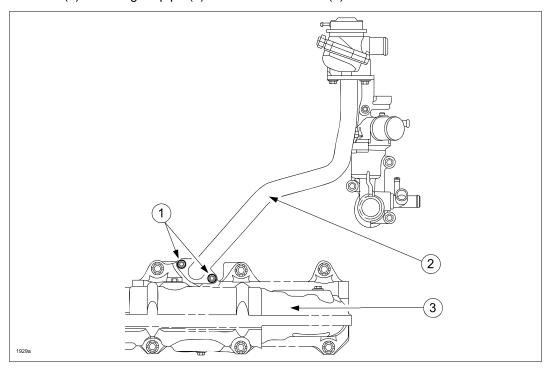
9. Remove 2 nuts (1) attaching air pipe (2) to exhaust manifold (3).

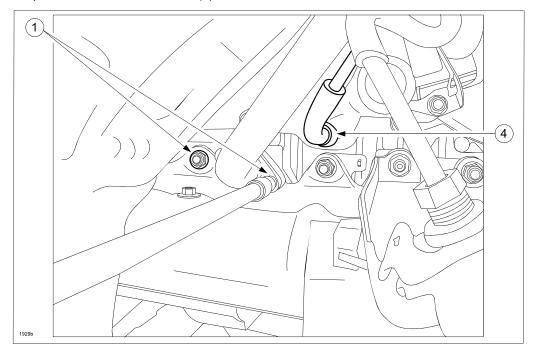
10. Disconnect port air bleed vacuum hose (4) from intake manifold.

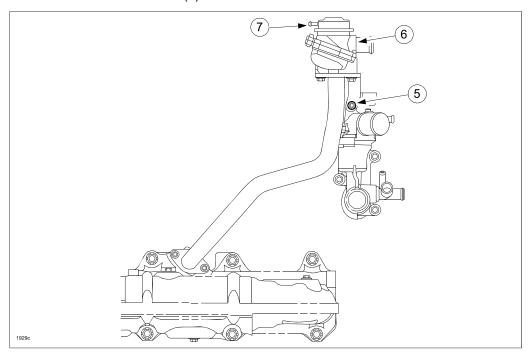
13. Remove air control valve bracket bolt (5).

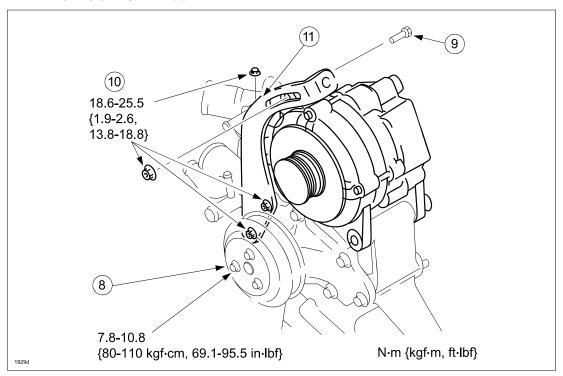
- 14. Disconnect main harness from air control valve bracket.
- 15. Disconnect upper hose (6) and vacuum line (7) from air control valve.
- 16. Position air control valve and air pipe out of the way by moving toward washer fluid reservoir.
- 17. Loose 3 water pump pulley bolts (8) but do not remove.

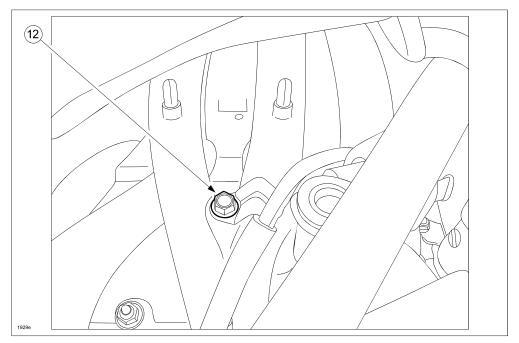
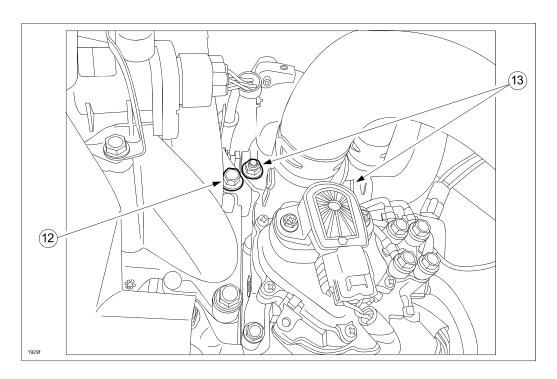
- 18. Loosen alternator belt tension bolt and remove attaching bolt and nut (9) from alternator and bracket.
- 19. Remove alternator belt.
- 20. Remove water pump pulley.
- 21. Remove 3 nuts (10) and alternator bracket (11).
- 22. Raise and support vehicle.
- 23. Remove 2 bolts (12) attaching port air bleed vacuum pipe.

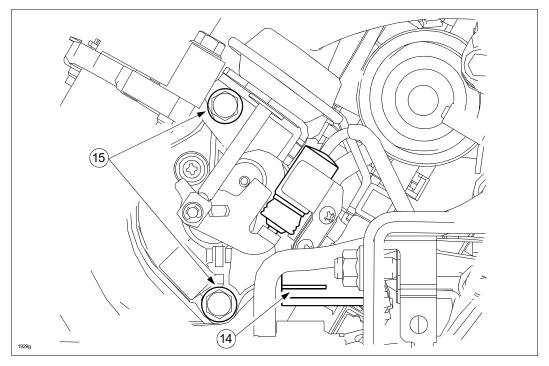
- 24. Remove 2 lower nuts (13) on thermostat housing.
- 25. Lower vehicle.
- 26. Remove 1 upper nut on thermostat housing.
- 27. Carefully position oil metering lines and bracket away from upper thermostat housing stud as to be able to remove thermostat housing from mounting studs.
- 28. Remove thermostat housing from mounting studs and position toward front of vehicle to allow access to SSV.
- 29. Position main harness to the side to allow access to SSV.
- 30. Disconnect SSV switch connector (14).

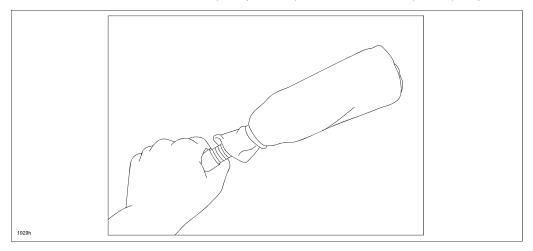
33. Wrap a shop towel around the handle of a screwdriver (or equivalent) and use a zip-tie to secure the towel at the handle end.

• Ensure the screwdriver handle (or equivalent) is as close to 1/2" (12mm) as possible.

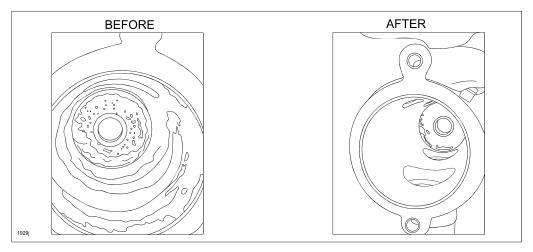
37. Using screwdriver with rag wrapped around the end, clean inner surface of SSV port.

Use care to restrict the amount of carbon debris that falls into the intake manifold ports.

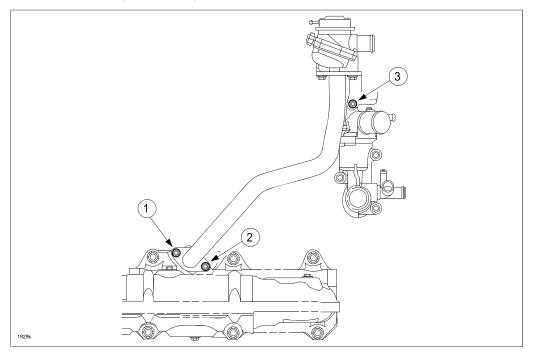
- Follow the tightening procedure below when installing air pipe and air control valve.
- Hand-tighten nuts (1, 2) first then hand-tighten bolt (3). Tighten nuts (1, 2 then 3) to 69.1-95.5 in-lbf. (7.8-10.8Nm).
