<b>Subject:</b>  REDUCTION OF TIE-DOWN PLUGS - SERVICE TIP	<b>Bulletin No:</b> 00-001/05
	<b>Last Issued:</b> 3/14/2005

2005 RX-8 (April 1, 2005 production and later)

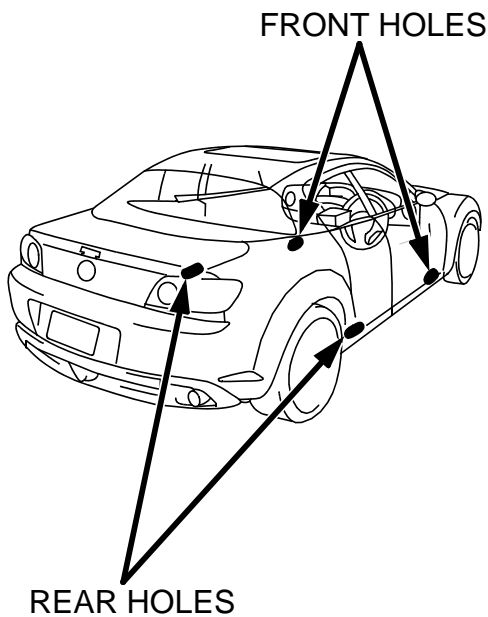
PRIOR TO APRIL 1 2005  
PRODUCTION DATE

On all RX-8 vehicles, there are four tie-down holes on the frame. 2 holes located at the front of the vehicle and 2 at the rear sides. All 4 tie-down holes must be plugged during pre-delivery inspection. For this purpose, 4 hole plugs are included with the vehicle in the glove box.

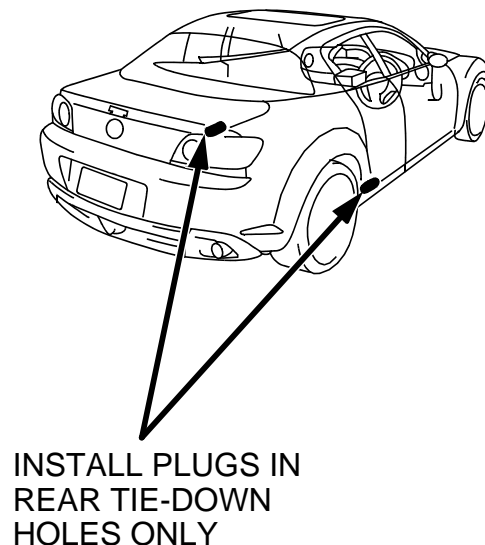
APRIL 1, 2005 PRODUCTION  
DATE AND LATER

Beginning with April 1, 2005 production, only 2 plugs will be in the glove box. Please fit these 2 plugs to the rear side tie-down holes only, leaving the front 2 tie-down holes open. Revised instructions will be included with the 2 tie-down plugs.
