Subject: SQUEAKING NOISE FROM SUNROOF	Bulletin No: 09-029/06
	Last Issued: 07/12/2006

2004-2006 Mazda RX-8 vehicles with VINs lower than JM1 FE**** **206829 (produced before May 25, 2006)

2006 Mazda5 vehicles with VINs lower than JM1CR**** **128630 (produced before May 25, 2006)

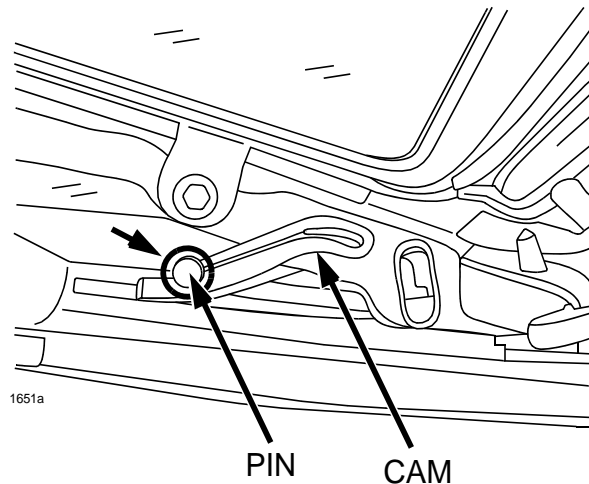
Some vehicles may exhibit a squeaking noise from the sunroof rail or guide when driving with the sunroof open. This squeaking noise is most likely caused by a looseness due to wear between the sunroof guide pin and the cam groove. To prevent this wear, the material and shape of the sunroof guide pin has been modified.

Customers having this concern should have their vehicle repaired using the following repair procedure.
