Subject: SUNVISOR PIVOT BROKEN	Bulletin No: 09-002/07
	Last Issued: 2/2/2007

2004-2005 RX-8

2006 RX-8 with VIN lower than JM1 FE**** ** 207643 (built prior to July 7, 2006)

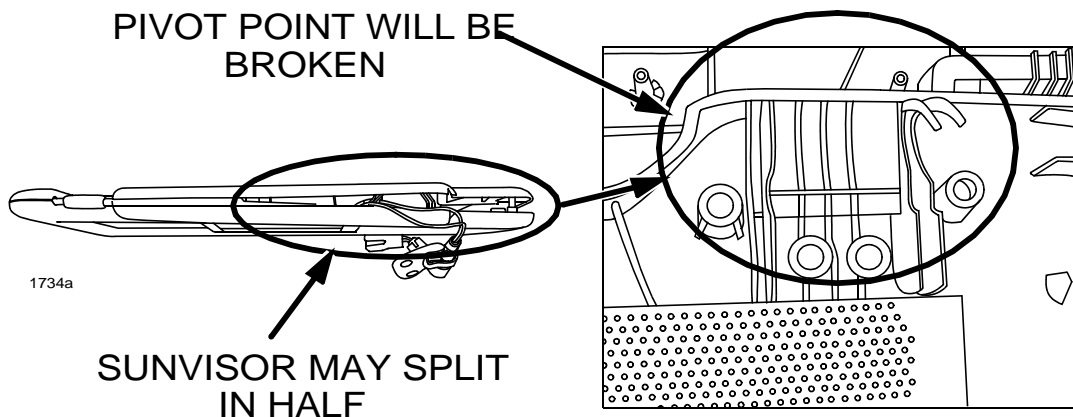
Some customers may experience the sunvisor broken at the pivot area and the upper and lower parts of sunvisor are split.

1. Verify customer concern.
2. Replace the sunvisor with modified part(s). Refer to Workshop Manual section 09-17 SUNVISOR REMOVAL / INSTALLATION.
3. Verify repair.
