Subject: TRUNK REQUEST SWITCH INOPERATIVE	Bulletin No: 09-013/07
	Last Issued: 4/3/2007

2006-2007 RX-8 vehicles equipped with Advanced Keyless System with VINs below JM1 FE**** ** 212388 (built before February 1, 2007)

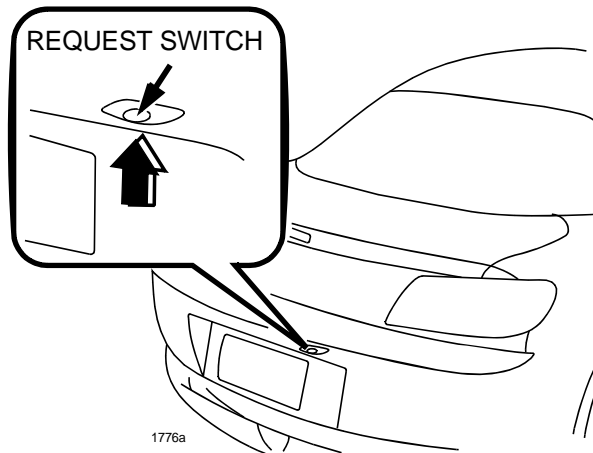
Some vehicles may experience intermittent operation of the trunk lid request switch. Driver and passenger door request switches operate properly.

Water may enter the switch, damaging the terminals and cause a malfunction. The switch design has been changed to prevent water damage. Customers having this concern should have their vehicle repaired using the following repair procedure.

1. Verify customer concern.
2. Replace trunk lid request switch.
