Subject: UNABLE TO ADJUST DRIVER-SIDE MANUAL SEAT LIFT	Bulletin No: 09-039/07
	Last Issued: 11/21/2007

APPLICABLE MODEL(S)/VINS

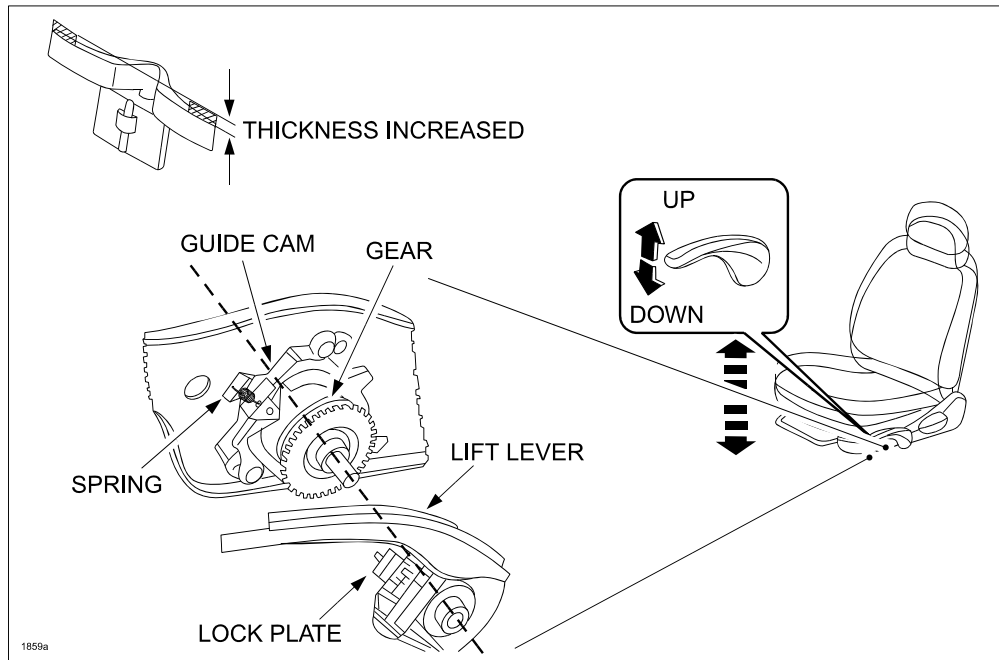
On some vehicles, the driver-side seat lift cannot be adjusted because the lock plate guide comes off the guide cam when operating the lift. If the lift lever is then operated with the lock plate guide off, the guide cam can be damaged. The shape of both ends of the guide cam has now been changed to stop the lock plate guide from coming off.

Customers having this concern should have their vehicle repaired using the following repair procedure.
