Subject: W / SUNROOF - OVERHEAD CONSOLE LID HARD TO OPEN	Bulletin No: 09-019/06
	Last Issued: 5/8/2006

2004-2006 RX-8 vehicles equipped with sunroof with VINs lower than JM1 FE**** ** 204221 (produced before March 11, 2006)

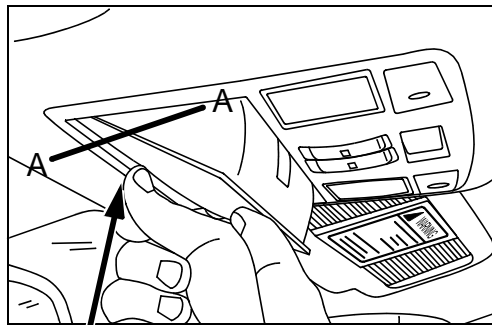
1614b

Some vehicles equipped with sunroofs may experience the overhead console lid hard to open at times. A burr may be present on the front edge of the overhead console housing, preventing the overhead console lid from opening.

**BURR CAN BE FELT
USING YOUR FINGER**

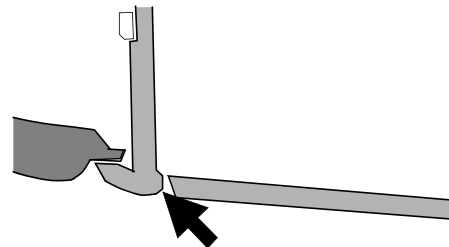
A-A CROSS SECTION

**BURR IS LOCATED
ALONG THIS EDGE**
