Service Bulletin

Subject: Bulletin No: 09-028/08

WATER IN COMBINATION LIGHT - IMPROPER SATELLITE RADIO ANTENNA CABLE ROUTING

2009 Mazda6

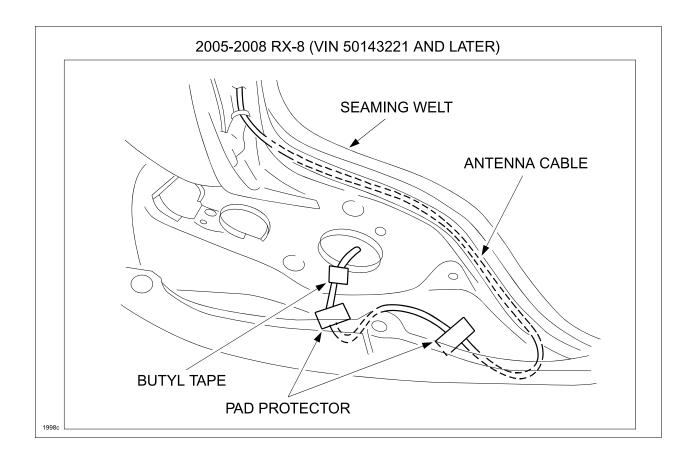
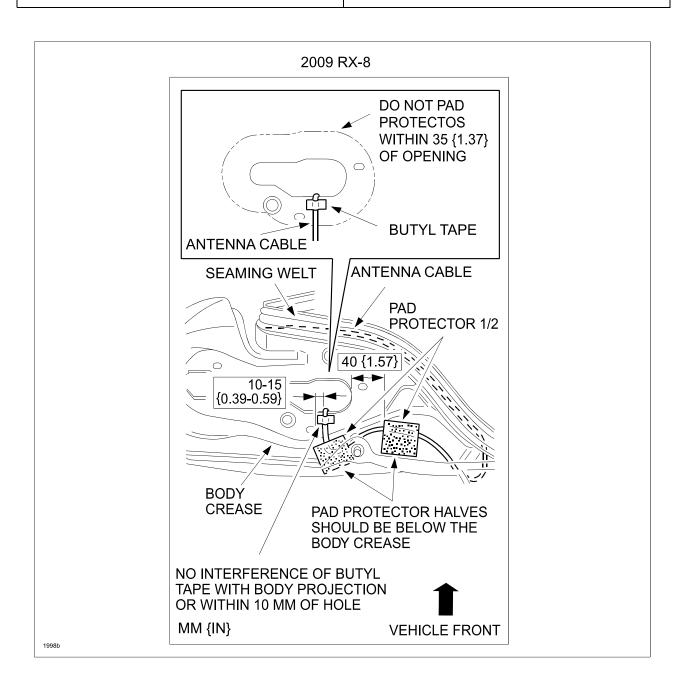
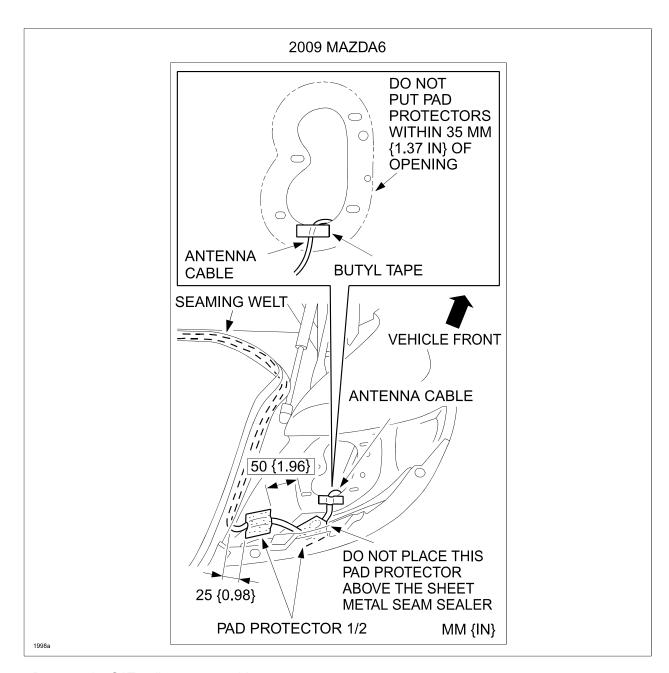
During installation of the SAT audio accessory, special attention is required when routing the antenna harness through the combination light opening in the vehicle body, and proper placement of pad protectors / butyl tape. Improper routing / placement of protector pads / butyl tape may result in water / condensation inside the combination light. Please refer to the following diagrams for proper antenna cable routing.

- Re-routing of antenna cable, labor for drying combination lights and/or replacement of combination lights due to water entry / condensation as a result of improper antenna cable routing are not warrantable repairs.
- 1. Verify customer concern.
- 2. On RX-8 vehicles, remove the Left rear combination light. On Mazda6 vehicles, remove the Right rear combination light.
 - 2005-2008 RX-8 Refer to MS3 repair information or Workshop Manual section 09-18 REAR COMBINATION LIGHT REMOVAL/INSTALLATION.
 - 2009 RX-8 Refer to MS3 repair information or Workshop Manual section 09-18 REAR COMBINA-TION LIGHT REMOVAL/INSTALLATION.
 - 2009 Mazda6 Refer to MS3 repair information or Workshop Manual section 09-18 REAR COMBI-NATION LIGHT REMOVAL/INSTALLATION.
- 3. Verify proper routing of the SAT radio antenna wiring using the diagrams shown.

- 4. Re-route the SAT radio antenna cable as necessary.
- 5. Remove back-up light, stop/tail light and rear turn light bulbs and sockets and bulbs from rear combination light assembly.
