© 2009 Mazda Motor of America, Inc.

Subject: CHATTERING NOISE / UNABLE TO ADJUST DRIVER-SIDE MANUAL SEAT LIFT	Bulletin No: 09-059/09
	Last Issued: 10/23/2009

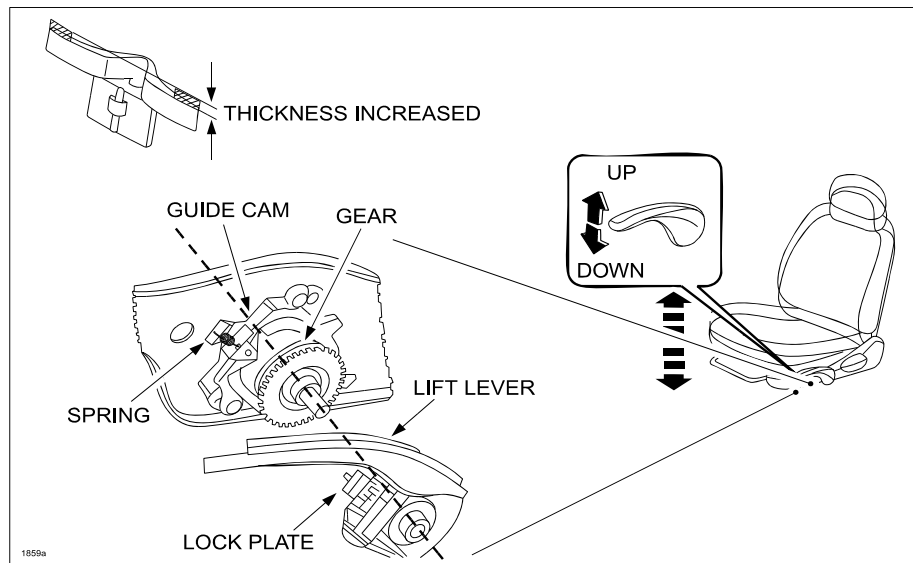
Some vehicles may exhibit a chattering noise and the driver-side seat lift cannot be adjusted because the lock plate guide comes off the guide cam when operating the lift. If the lift lever is then operated with the lock plate guide off, the guide cam can be damaged. The shape of both ends of the guide cam has now been changed to stop the lock plate guide from coming off.

Customers having this concern should have their vehicle repaired using the following repair procedure.
