<b>Subject:</b>  <b>CLUNK NOISE FROM SEAT WHEN BRAKING</b>	<b>Bulletin No:</b> 09-060/09
	<b>Last Issued:</b> 10/23/2009

- 2006-2010 MX-5
- 2004-2010 RX-8
- 2004-2010 MAZDA3
- 2006-2010 MAZDA5
- 2003-2010 MAZDA6
- 2007-2010 CX-7
- 2007-2010 CX-9

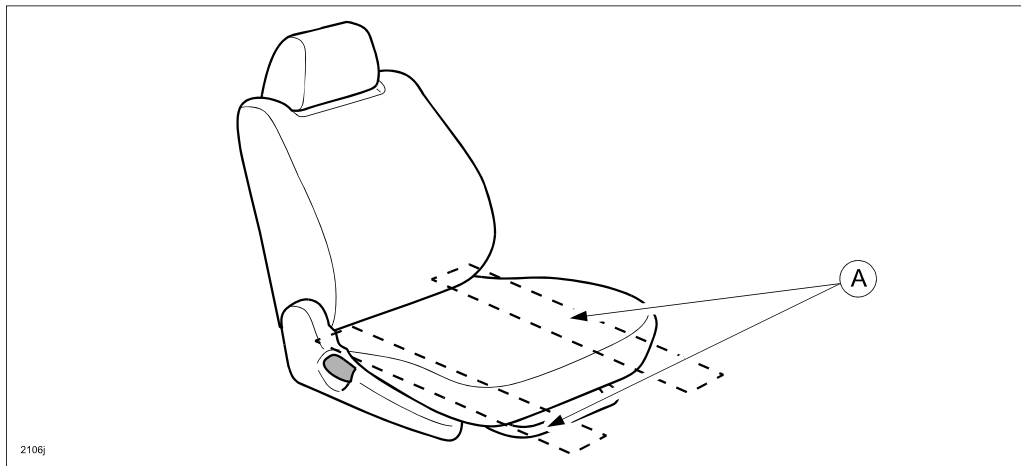
Some vehicles may exhibit a clunk noise coming from the front seat when braking. The noise may be caused by both seat rails (A) being out of position.

Customers having these concerns should have their vehicle repaired using the following repair procedure.
