<b>Subject:</b>  <b>SQUEAKING NOISE FROM LEATHER SEATS</b>	<b>Bulletin No:</b> 09-062/09
	<b>Last Issued:</b> 10/23/2009

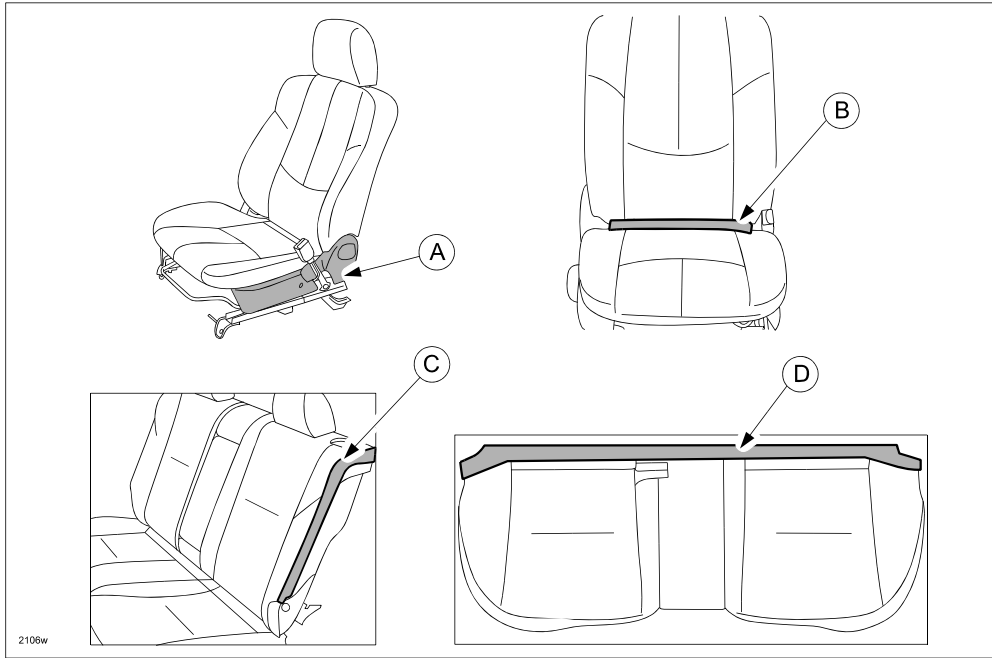
1. Verify customer complaint.
2. Apply masking tape around surface areas A, B, C & D where silicone grease will be applied.
  - Area A - Center console and cushion contact each other (front seat).
  - Area B - Cushion and seatback contact each other (front seat).
  - Area C - Seatback and trunk contact each other (rear seat).
  - Area D - Cushion and seatback contact each other (rear seat).

3. Apply silicone grease to areas (A, B, C & D), spraying over each area 2 ~3 times.
4. Using a heat gun, apply heat to silicone until silicone is no longer sticky to the touch.

**CAUTION: DO NOT allow the heat gun to get too close to the surface of the seat. Too much heat may discolor the seat surface.**
