<b>Subject:</b> <b>SQUEAKING NOISE FROM SEAT BACK DUE TO FRAME AND SEAT BACK PAD CONTACT</b>	<b>Bulletin No:</b> 09-069/09
	<b>Last Issued:</b> 11/12/2009

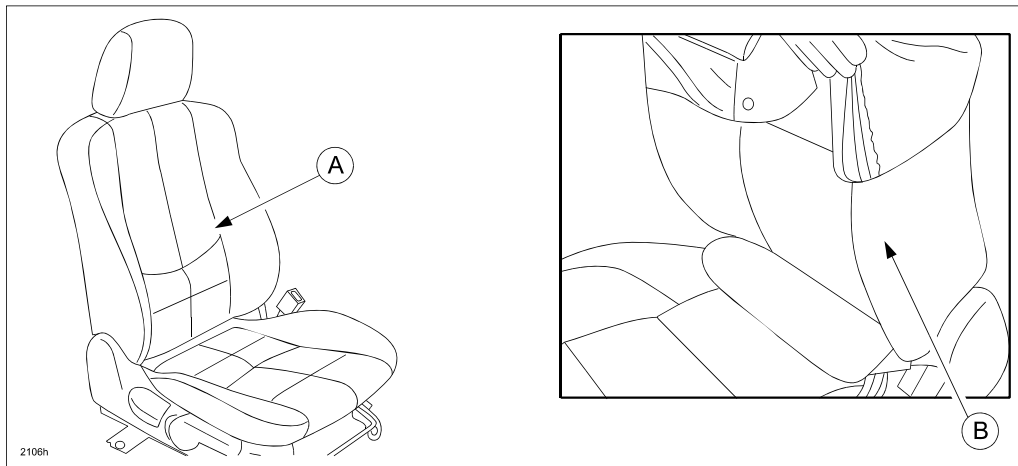
Some vehicles may exhibit a squeaking noise coming from the front seats (A). This noise may be caused by contact between the seat frame and the urethane seat back pad (B).
