<b>Subject:</b> <b>SQUEAKING NOISE FROM SEAT BACK DUE TO FRAME AND SPRING CONTACT</b>	<b>Bulletin No:</b> 09-064/09
	<b>Last Issued:</b> 10/27/2009

- 2006-2010 MX-5
- 2004-2010 RX-8
- 2004-2010 MAZDA3
- 2006-2010 MAZDA5
- 2003-2010 MAZDA6
- 2007-2010 CX-7
- 2007-2010 CX-9

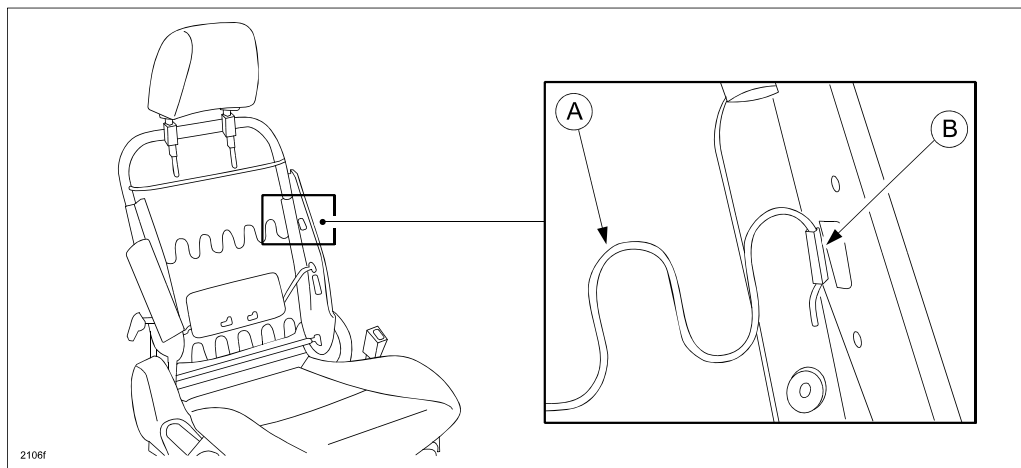
Some vehicles may exhibit a squeaking noise coming from the front seat back due to contact between the seat frame and seat frame spring.

1. Verify customer complaint.
2. Remove the headrest.
3. Remove the seat trim and seat back pad according to 2010 Mazda3 MS3 online instructions or Workshop Manual (section 09-13 FRONT SEAT BACK TRIM REMOVAL/INSTALLATION).
4. Widen clamp (B) to remove spring (A).
