### **Turbo Renesis Failure**

The following information has been compiled from the ongoing R&D at Pettit. Since late 2003 when we opened the first failed turbo Renesis, we have been testing and evaluating our modifications to improve performance and reliability for both the naturally aspirated and forced induction Renesis setups.

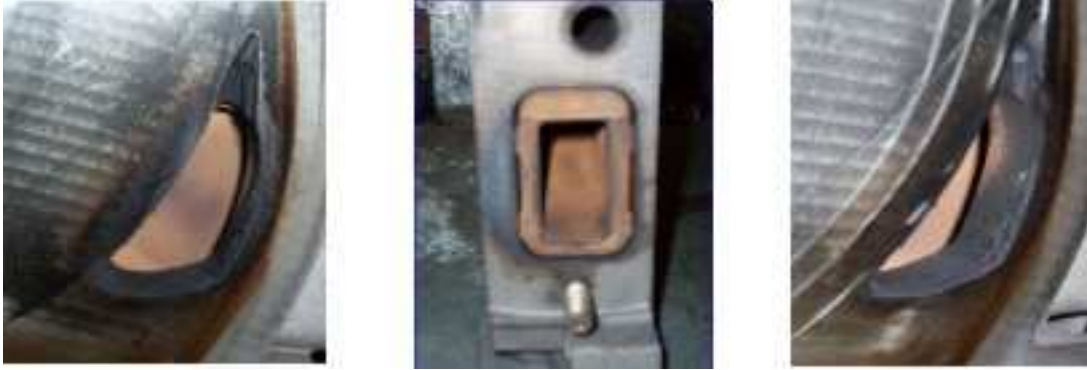
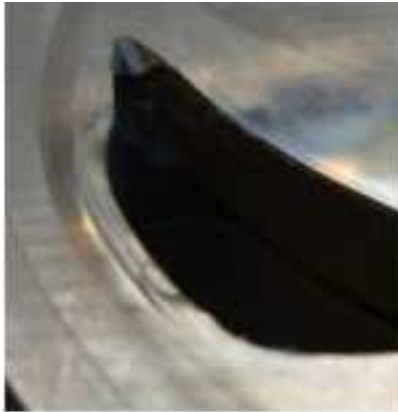
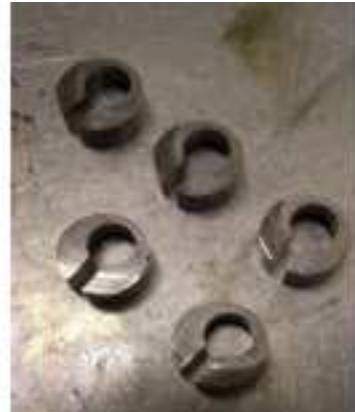
Some extreme failure examples (pictured below) are from engines which had turbo systems designed for low boost but then run higher boost, this raises back pressure ratios as high as 3:1 compressing hot exhaust gasses between the exhaust port and turbo, superheating the exhaust port areas as well as delicate internal parts like side seals, corner seals and even the springs that hold them seated. These conditions also cause the oil metering systems protective lubricant to vaporize increasing friction and wear, which generates more heat, friction and wear eventually causing hard starting and / or a weak idle condition on hot engines. At this point it is a good idea to send in the engine before a catastrophic failure leaves you stranded and ruins some expensive parts.

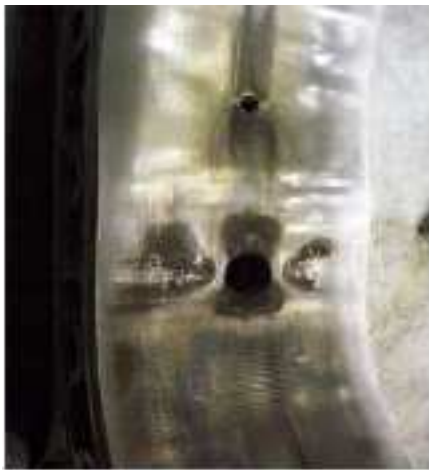
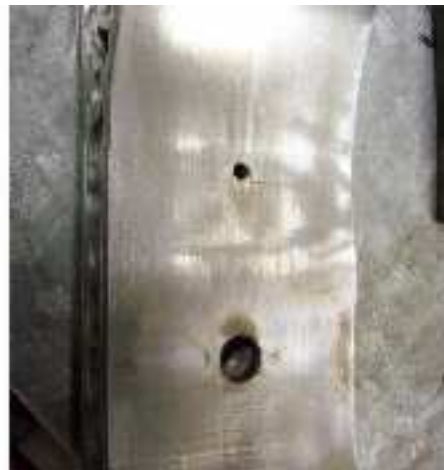
The following pictures from turbo engines show results of before and after the modifications as tested on a 350whp turbo Renesis, after several road races in a **Diasio** Sports Racer, the left picture shows an unmodified housing with obvious seal leakage at the leading plug and minor axis area. The right picture shows little or no blow by in the same area, the modifications have made a significant improvement in this area, adding longevity while maintaining top performance.
