Service Bulletin

Subject: COOLANT LEVEL WARNING LIGHT COMES ON	Bulletin No: 01-040/10
	Last Issued: 07/13/2010

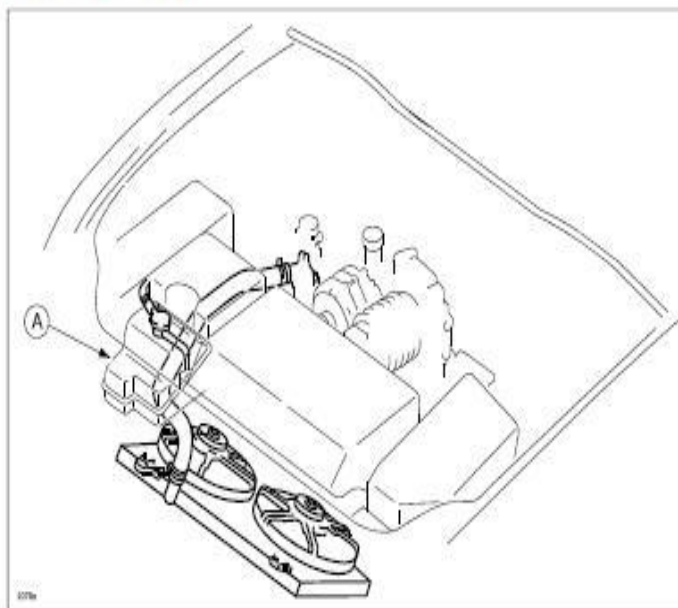
The coolant level sensor float in the coolant reserve tank (A) is deteriorated and absorbs coolant. The float gets heavy, and sinks, causing the the coolant level warning light comes on. As a mass-production change, the design of the float has been modified.

Customers having this concern should have their vehicle repaired using the following repair procedure.
