Service Information

Mazda Motor Corporation

Category S	Technical	Ref. No. E031/10	Page 1 of 12
Coverage <input type="checkbox"/> Distributor only <input checked="" type="checkbox"/> Please inform your dealers		Date Issued January 19, 2011	
Please convey this information to your <input type="checkbox"/> Director <input checked="" type="checkbox"/> General Manager <input checked="" type="checkbox"/> Warranty Dept. <input checked="" type="checkbox"/> Parts Dept. <input checked="" type="checkbox"/> Training Dept. <input checked="" type="checkbox"/> Field Rep.		Date Revised	
Applicable Model All models	Applicable Countries or Specifications Worldwide

Subject: Tips for Paint Damage Caused by External Factors

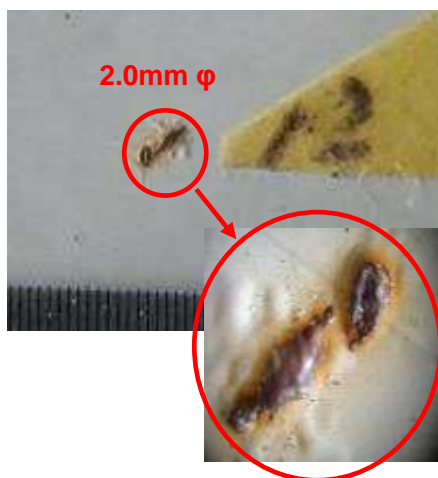
(1)Bug shell

While driving, when a bug hits the vehicle, the bug is crushed with the impact, spraying its body fluid. Enduring contact of the body fluid (organic acid) to coating causes damage to the coating. Coating dissolution by acid has the same mechanism as dissolution by acid rain. But the bug's body fluid is more acidic, and the bug shell plays a role like a packing, making it more difficult to move body fluid. So it tends to stay in the same spot, causing a bigger degree of damage to coating.

To protect coating from bugs, there's no effective prevention measure for bugs attached while driving. Then, wash the vehicle in water right away when the bug is attached. If it's not possible, wipe it off with a cloth or tissue paper etc.

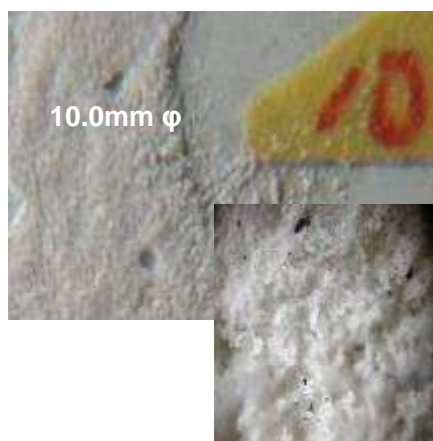
(2)Bird and bug droppings

Coating damage by bird or bug droppings differs depending on types of bird's or bug's feed, amount of droppings, weather (temperature) condition, elapsed time etc. Level of damage also varies ranging from color change to top coat peeling. Coating dissolution by acid is the same one as dissolution by acid. But droppings of birds which ate acidic feed such as bug, fish and fruit are more acidic, making the degree of coating damage heavier.

To protect coating from bird or bug droppings, wash the vehicle with water right away after the bird/bug droppings attached to the coating. If it's not possible, wipe it off with a cloth or tissue paper etc.

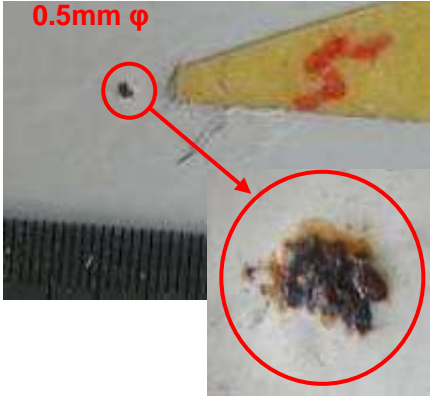
(4)Iron powder

0.5mm φ

<Factor>
Iron powder generated by casting plant and railway track etc. sticks into the top coating, being exposed to rain or water in the air and leading to poor appearance due to corrosion. Also, it causes dullness due to rough coating surface, and unevenness of wax wipe-off.

<Treatment>
Corroding iron powder on the coating can be removed by cleaner or compound. But iron powder remover is most efficient.

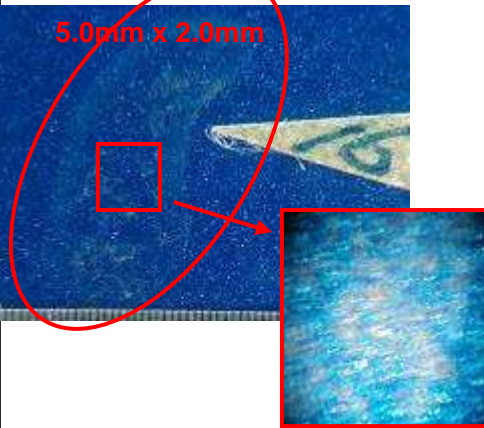
(5)Water marks

5.0mm x 2.0mm

<Factor>
Stain which looks like dried waterdrop. Contaminant included in water is left after water evaporation. Water is prone to absorb contaminant easily.

<Treatment>
It can be prevented by wiping waterdrop off completely, instead of drying waterdrop naturally.

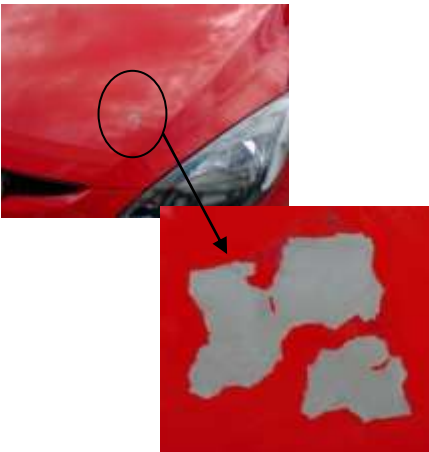
(6)Fruits

<Factor>
While the vehicle is parked under or nearby a tree, fruits (such as cherry fruits etc.) drop from the tree to the paint surface. Paint is damaged due to fruit juice (organic acid) attaching to the paint surface.
Though the dissolution of paint surface caused by acid has the same mechanism as acid rain, acidity of fruits is higher than that of acid rain. In addition, fruit itself plays a role like a pad which makes fruit juice difficult to move and stay in the same spot, resulting in a larger degree of the paint surface damage.

<Treatment>
Like insect's dead body, we don't have any effective preventive measures for fruits. But in order to protect the painting, if there's anything attached to the painting surface, wash it away with water immediately. If it cannot be washed with water, wipe it out with fabric or tissue paper etc.

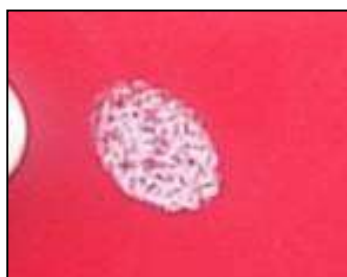
(7) Acid rain

Due to high temperature under the sun, acid in the waterdrop was condensed and penetrated into the paint coating, causing the depression.

Acid raindrop falls on the paint surface, becomes more acidic after evaporation, and etches off the paint surface.

If the attached raindrop is left untouched, acid is condensed after water evaporation, which decreases pH value.

Due to temperature rise, paint is softened and vulnerable to acid penetration, being prone to be damaged. If body temperature becomes 80 degrees C or more, the damage will be heavier.

Explain that it is an external factor, not a paint failure at production. This will not be handled as warranty repair.

If it is like a stain or similar with no depression confirmed by the fingertip, polish it with compound. If it doesn't disappear, polish it with waterproof paper and compound for finishing. If it's not fixed yet, grind it smoothly and paint it again.

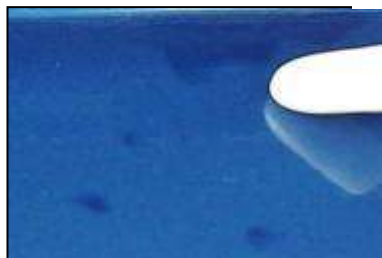
Due to high temperature under the sun, acid in the waterdrop penetrated into the paint coating, damaging aluminum pieces.

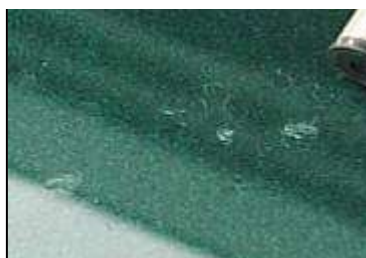
Trace of the paint surface etched off by acid because waterdrops were left under the scorching sun.

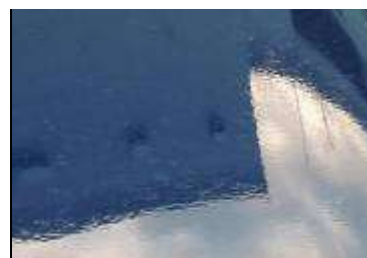
After rain, raindrops were left under the scorching sun, causing paint damage due to acid.

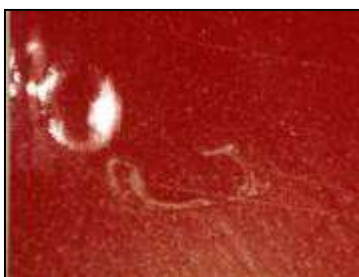
(8) Sooty smoke

After rain, raindrops were left under the scorching sun, paint surface was eaten away by acid.

Substances emitted by the plant (sooty smoke) fly and fall on the body, damaging the paint coating after they are mixed with rain water and become acid water.

Smoke from the plant pours on the vehicle body and is mixed with rainwater or dew. If it's left as is, acid is condensed due to water evaporation and lowers the pH value. Additionally, pH value is partially lowered through the evaporation process of droppings on the paint surface.

Explain that it is an external factor, not a paint failure at production. This will not be handled as warranty repair.

If it is like a stain, polish it with compound. If it doesn't disappear or paint coating is removed, polish it with waterproof paper and compound for finishing. If it's not fixed yet, grind it smoothly and paint it again.

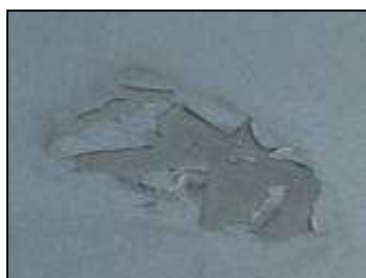
Paint was etched off and removed.

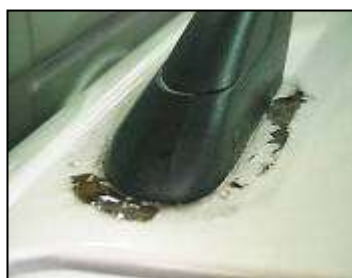
After rain, acidic water gathered partially, penetrated in the paint and caused peel-off. (roof rail)

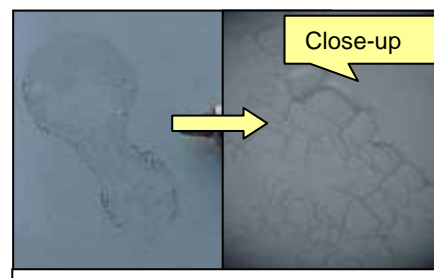
Acid level of waterdrop increased due to temperature rise, which damaged the paint coating and caused the paint crack.

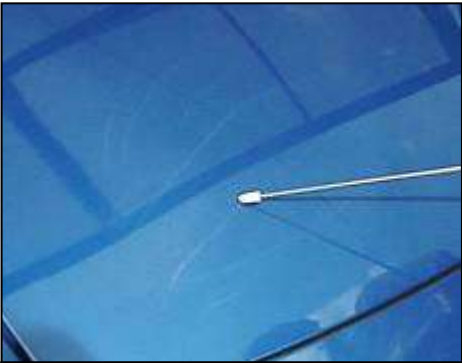
(1) Scratch

<Factor>
- A symptom that external factors scrape off the paint surface, causing diffuse reflection of the scraped area that looks white.

<Cause>
- The surface was wiped off with foreign material attached.
- When the surface was polished with wax or compound, polished finish and wipe-off wasn't enough.
- The bird dropping was wiped off without knowing that it included pebbles.
- Paint was scraped off due to hit of clothes and bags etc.

<Countermeasure>
- Explain this is not a production concern of paint. Will not be handled as warranty repair.
- Minor scratch can be polished with compound. If it's a severe scratch, Polish it with #2000 or equivalent waterproof paper and finish it with compound. If it's not fixed yet, grind it smoothly and paint it again.

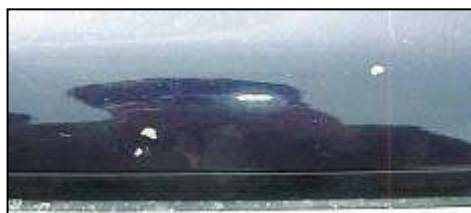
Mark of coating removal caused by flying stone. (Hood)

Flying stones etc. hit the coating while driving or under strong windy weather (typhoon), removing the coating with a shock.

- Explain this is not a production concern of paint. (external factor). This will not be handled as warranty repair.
- Confirm the state of peeling, if the base coat isn't visible, polish the surface with compound. If it's not fixed yet, polish it smoothly and paint it again.
- As a quick cure, remove the foreign material in the peeled area and paint it with touch-up paint.

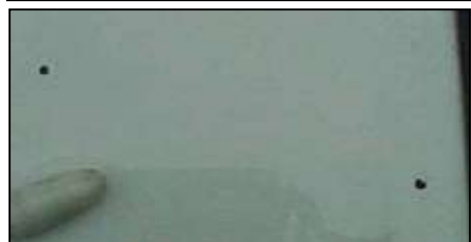
Mark of coating removal due to pebbles scattered by helicopter's wind pressure. (The whole surface exposed to wind had the same symptom. Same as glass.)

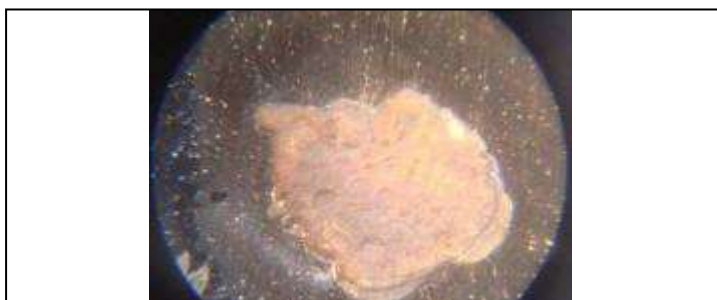
Right after the peeling, impact area is burned and whitened. Edge of peeled area is scraped off at a sharp angle.

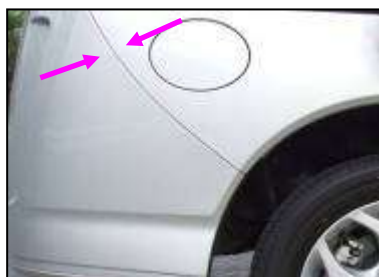
(1) Wrong color, color deviation (Body, Bumper etc.)

- A phenomenon that colors of body and bumper (plastic) paint look different when the vehicle is seen under the sun.

- Vehicle body and plastic parts (bumper, molding etc.) are painted in different plants, using paints with different ingredients.⁽¹⁾ Although metallic paint is sprayed with the automatic painting machine,⁽²⁾ colors of paint look different because configuration of aluminum pieces included in paint is uneven and doesn't face in the same direction⁽³⁾ due to difference of production plant.

- This phenomenon is not a production concern of paint. This will not be handled as warranty repair.

- As described in the above "Cause", even though the bumper is replaced and painted again, it's difficult to match it with body color completely, with some color difference left.

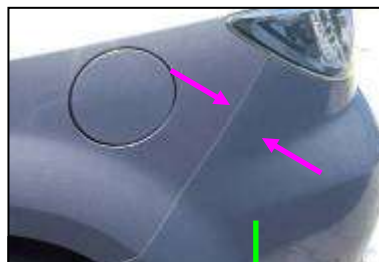
It looks different depending on angles or light conditions.

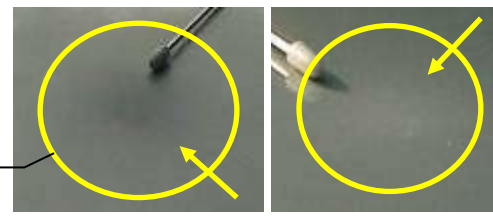
Repainting may cause mottling that looks light or dark depending on viewpoint angles.

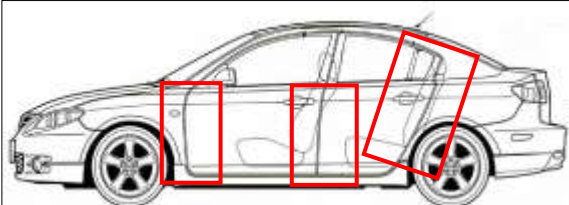
During inner spraying, paint was sometimes attached to the surface due to overspray.

Due to small interval to the next vehicle, automatic painting couldn't be finished on time and it was painted manually.
