Subject: MIL ON WITH DTC P2004	Bulletin No: 01-012/10
	Last Issued: 02/11/2010

2004 RX-8 (6-Speed MT) with VINs from JM1FE17**4* 100001 to JM1FE17**** 129580 (built from February 2003 through December 26, 2003)

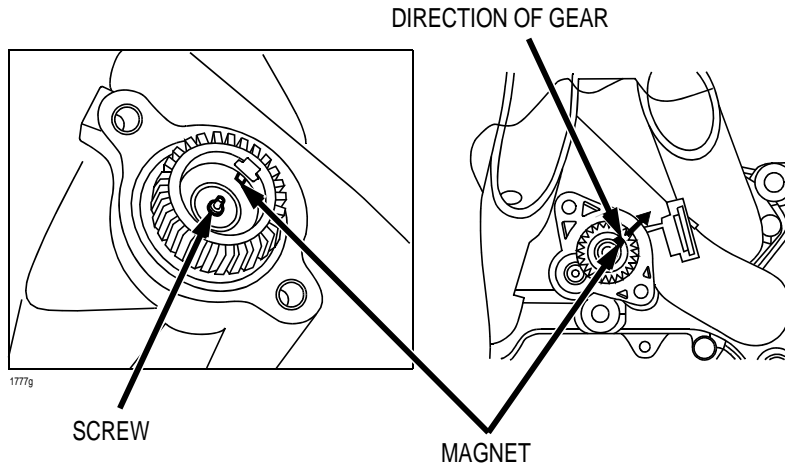
Because of excessive backlash in the APV gear, the APV fully closed position is misjudged by the PCM causing P2004 to set in PCM memory. As a mass production change, the positioning of APV shaft and gear have been changed.

8. Rotate the APV gear counterclockwise until it stops, then carefully remove and discard the APV screw as a new one will be used.

9. Rotate the APV gear fully clockwise until it stops, then remove the APV gear.

CAUTION: Use care not to rotate the APV gear shaft while the gear is removed.
