Subject: CONTACT MARKS ON CENTER OF SIDE SILL	Bulletin No: 09-001/05
	Last Issued: 1/20/2005

2004-2005 RX-8 - With VINs lower than of JM1FE*****147469 (vehicles built before October 18, 2004)

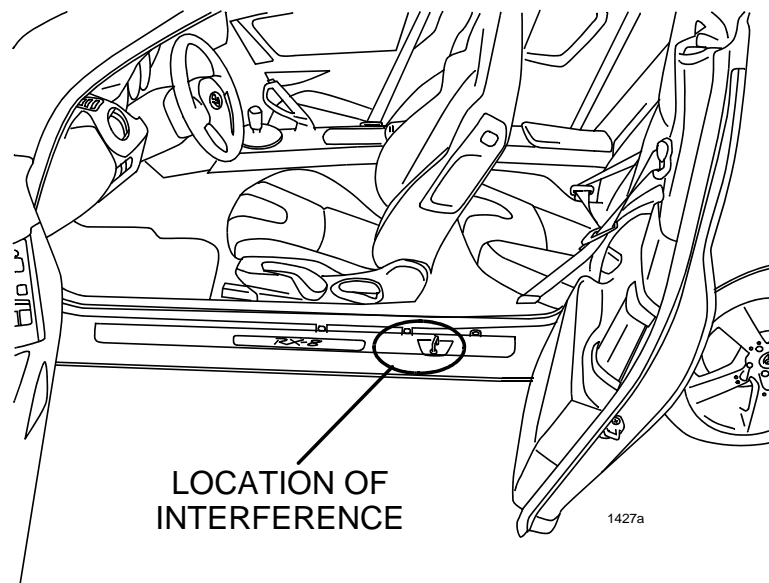
Some customers may notice contact marks on the center area of the side sill. The weather-strips of the front and rear doors may interfere with the body, resulting in contact marks on the side sill. Sand and dust may become trapped between the weather-strips and side sills due to excessive sealing strength of the weather-strips, and may leave marks due to body vibration during driving.

A mass production change has been carried out to prevent the contact marks through the addition of protective films on the right and left side sills. Customers having this concern should have their vehicle repaired using the following repair procedure.
