<b>Subject:</b>  COOLANT LEVEL WARNING LIGHT COMES ON	<b>Bulletin No:</b> 01-040/10
	<b>Last Issued:</b> 07/13/2010

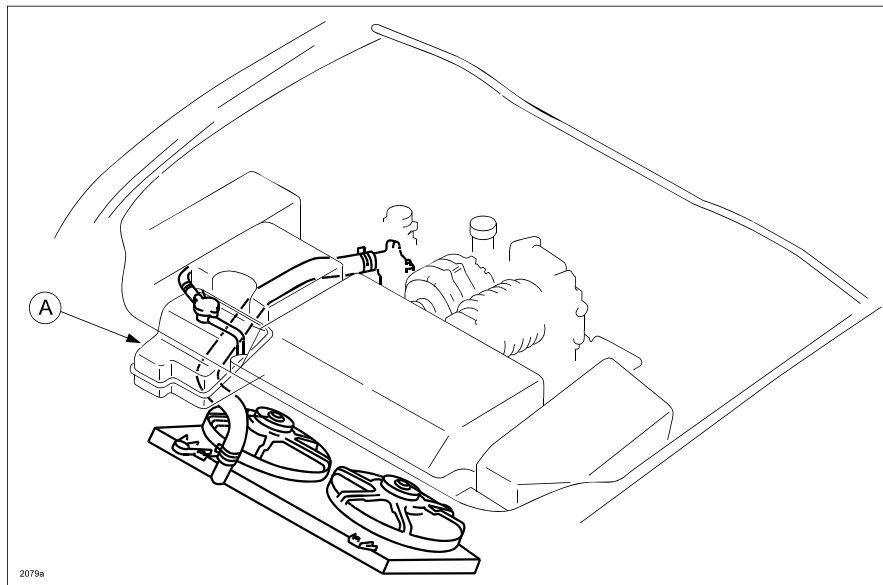
The coolant level sensor float in the coolant reserve tank (A) is deteriorated and absorbs coolant. The float gets heavy, and sinks, causing the the coolant level warning light comes on. As a mass-production change, the design of the float has been modified.

2. Replace the coolant reserve tank (A) with a modified one. Refer to MS3 online service information or Workshop Manual section 01-12 - COOLANT RESERVE TANK REMOVAL/INSTALLATION [13B-MSP].

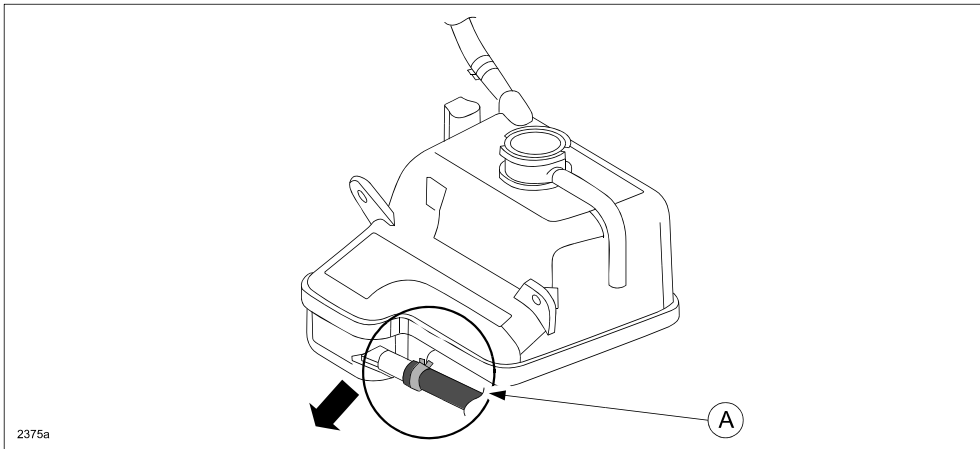
**NOTE:** When removing the water hose (A) from the reserve tank, remove from the radiator upper tank side first, then remove the reserve tank side. Otherwise the nipple on the radiator upper tank may break.
