Service Information

Category T	Technical	Ref. No. E019/11	Page 1 of 1
Coverage Distributor only Please inform your dealers		Date Issued September 12, 2011	
Please convey this information to your Warranty Dept. Parts Dept. Training Dept. Field Rep.		Date Revised	
Applicable Model All models		Applicable Countries or Specifications Worldwide

Subject: Headlamp inner condensation due to improper socket covers installation

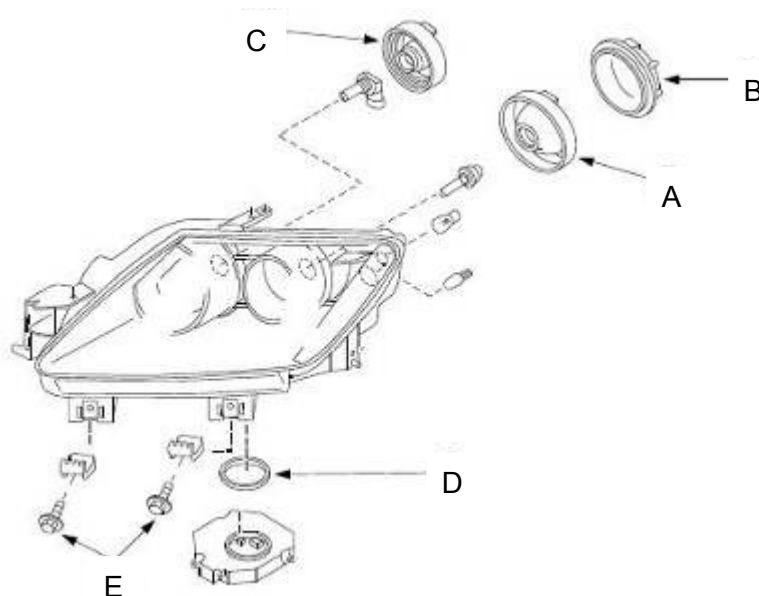
In some cases you may find that the Bulb Seal No. 1 (A) or HID Bulb Seal No. 1 (B) and Bulb Seal No. 2 (C) socket covers have not been correctly installed or are missing due to improper prior repairs (i.e., customer replacing the headlamp bulbs or body shop not transferring them when replacing the headlamp unit(s) due to a collision).

Any damage caused by missing/incorrect installation of above mentioned socket covers, HID module seal (D), or missing bumper brackets (E) is not covered by warranty.

When dealing with customer complaints of excessive condensation and/or water within the headlamp unit, first determine if all the bulb sockets are present and correctly installed.
