| Subject: AUXILIARY PORT VALVE (APV) REMOVAL CAUTION | Bulletin No: 01-034/11 |

2004-2008 Mazda RX-8 with High Power

2009-2011 Mazda RX-8

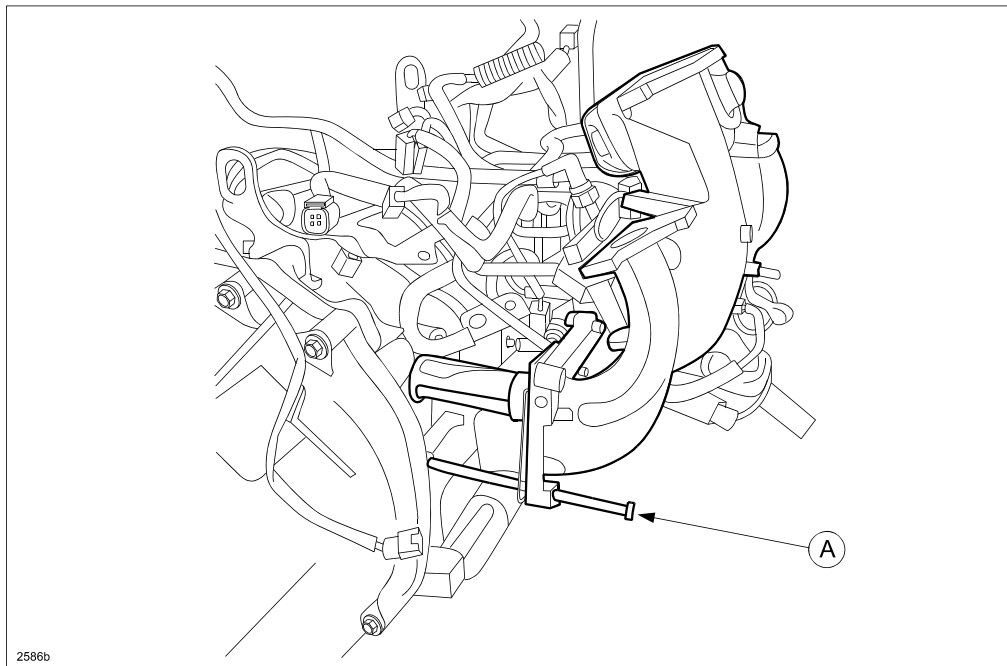
NOTE: When removing the inlet manifold, use two long bolts (A) [M8 - 1.25x220 hex bolt] in both the lower outer bolt holes to help support the manifold and slide out the APVs. This will take pressure off the APV arms so they will have less chance of breaking.
