Mazda Motor Corporation

Category <b>S</b>	<b>Repair Guidance</b>	Ref. No. R038/08	Page 1 of 2
Coverage <input type="checkbox"/> Distributor only <input checked="" type="checkbox"/> Please inform your dealers		Date Issued April 24, 2008	
Please convey this information to your <input type="checkbox"/> Director <input checked="" type="checkbox"/> General Manager <input checked="" type="checkbox"/> Warranty Dept. <input checked="" type="checkbox"/> Parts Dept. <input checked="" type="checkbox"/> Training Dept. <input checked="" type="checkbox"/> Field Rep.		Date Revised October 23, 2008	
Applicable Model  RX-8 (FE/SE)		Applicable Countries or Specifications  Worldwide

## Subject: Unusual Noise from Front of Vehicle / Front Stabilizer Control Link Breakage

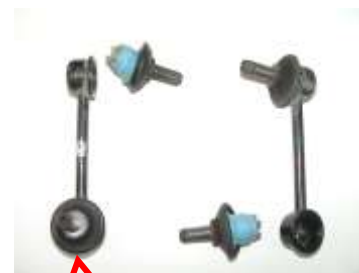
Some vehicles may exhibit an unusual noise from the front side of the vehicle.

The plastic part connecting the stabilizer control link ball joint to the link is broken apart. As a result, the front lower arm and stabilizer bar are not connected.

When you encounter a customer complaint on this concern, replace the front control links with service ones.

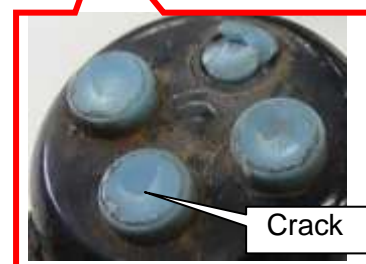
Due to excessive impact, the swaying friction of the ball joint increases momentarily and the ball seat receives the load. After this has been repeated some times, a fatigue breakage is caused on the caulking part of the ball joint.
