Subject: SNAPPING NOISE WHEN TURNING AT LOW SPEED - 18" WHEELS	Bulletin No: 02-002/04
	Last Issued: 2/23/2004

2004 RX-8 - VIN Range - JM1FE17**40100000 - 40128212

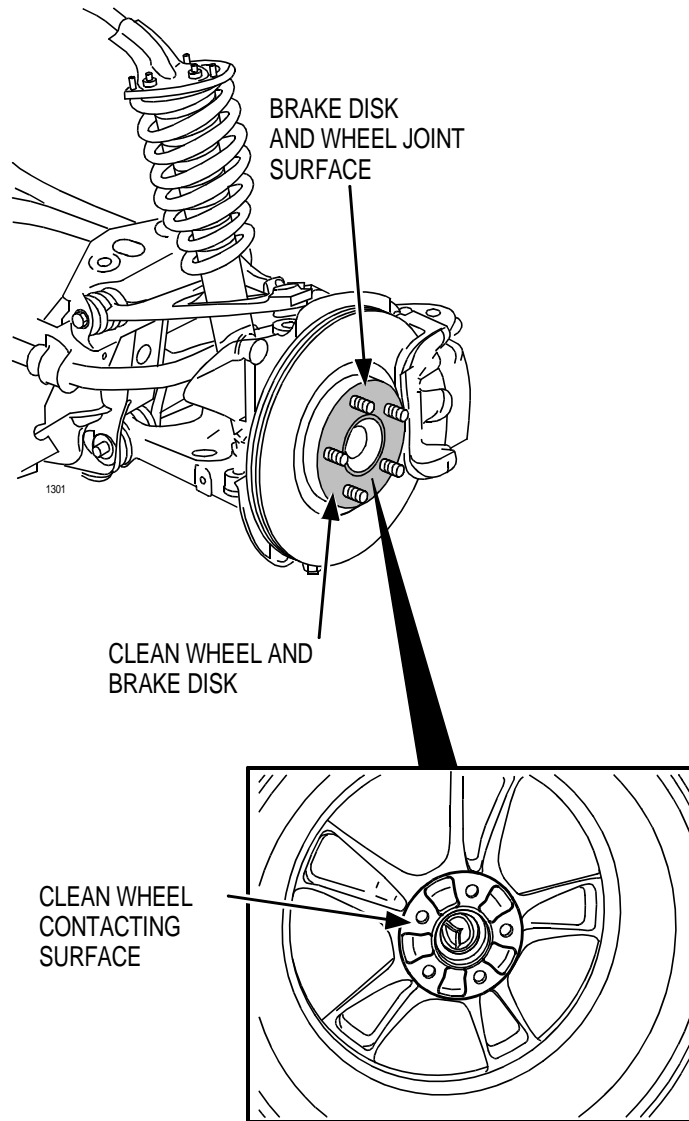
When the vehicle is making a turn with the front tires receiving side force, the joint surface of the aluminum wheel slightly deforms, allowing the wheel and brake disc to slip against each other. This slippage causes the anti-corrosion treatment to peel off the brake disc. The frictional co-efficient between the wheel and brake disc joint surface changes. As a result, a stick-slip noise occurs.

1. Verify customer concern.
2. Remove the front tire / wheel assemblies.
3. Remove anti-corrosion treatment (black coating) from mounting surface of brake disc and wheel with #100 sand paper, and clean mounting surface of brake disc and wheel with brake cleaner.
4. Re-tighten lug nuts to 147 N.m (108 ft-lb).

Note: The Workshop Manual specifies a lug nut torque of 88-118 N.m (65-87 ft-lb), but for a field counter-measure against this noise, be sure to torque the lug nuts to 147 N.m (108 ft-lb). Revised wheel torque specs should be used anytime wheels are removed from the vehicle (wheel rotations etc..).
