Subject: DRIVER SIDE AIR BAG RATTLE	Bulletin No: 08-004/04
	Last Issued: 9/3/2004

2004 RX-8 - With VIN's lower than JM1FE17**40126795

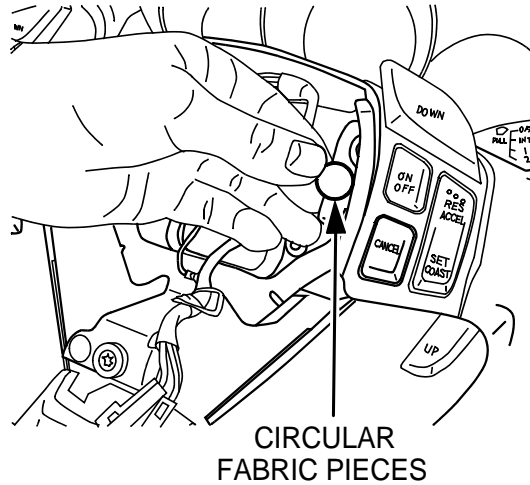
- The fabric material attached over the locator pin hole for the driver's side air bag module is worn and the air bag module locator pin comes into contact with the locator pin hole in the steering wheel frame causing the noise.
- During vehicle production, the fabric material is torn and the air bag module locator pin comes into contact with the locator pin hole in the steering wheel frame causing the noise.

1. Verify customer concern.
2. Remove the driver-side air bag module according to the Workshop Manual section 08-10 DRIVER-SIDE AIR BAG MODULE REMOVAL/INSTALLATION.
3. Peel adhesive backing from circular fabric pieces & install over locator pin holes in steering wheel frame.

NOTE: The kit comes with 3 circular fabric pieces, only 2 are required for this repair. Do not remove existing fabric pieces from locator pin holes. Install new circular fabric pieces over old.
