Subject: CLEARING ECCENTRIC SHAFT PLATE PROFILE MEMORY FROM PCM	Bulletin No: 01-010/08
	Last Issued: 8/25/2008

2004-2010 RX-8

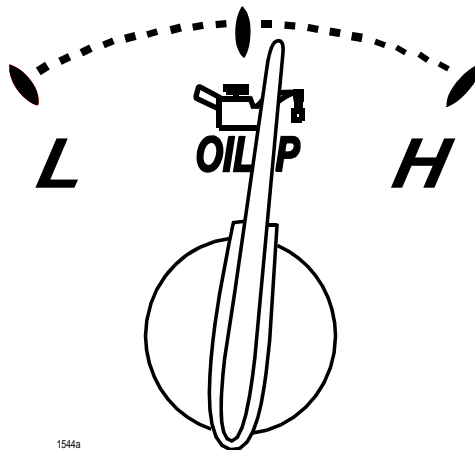
OIL PRESSURE GAUGE NEEDLE WILL
MOVE TO RIGHT OF CENTER SLIGHTLY

1. Turn ignition switch to "ON" position, but do not start engine.
2. Pump the brake pedal at least 20 times within 8 seconds after the ignition switch is turned ON.
