<b>Subject:</b> <b>MULTI-MODEL - CONDENSATION / FOG IN FRONT AND REAR COMBINATION LIGHTS</b>	<b>Bulletin No:</b> 09-057/10
	<b>Last Issued:</b> 12/23/2010

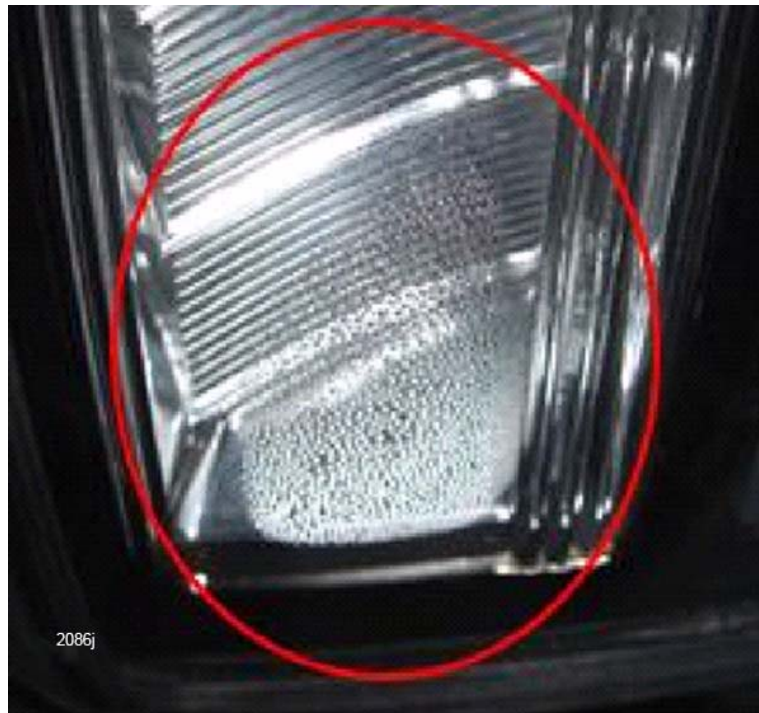
Some condensation/fogging on the lens is considered normal.

Explain to the customer that this is a natural phenomenon and not a quality defect. DO NOT attempt repairs as this is considered normal, and is NOT covered under Warranty. Replacing the light unit will not correct this symptom.

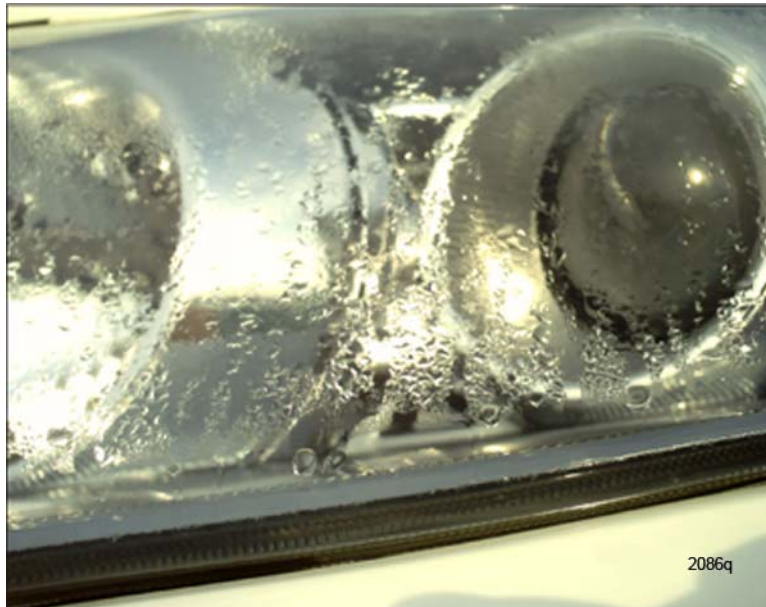
Water entry is where rain water comes into the inner light and stays as waterdrops on the inside of the lens. The possible causes of "water entry" because of a part issue are:

- Poor sealing joint between the lens and housing.
- Missing or poor sealing of gasket. (NOTE: If the light unit was previously repaired and any seals are missing, this is not covered under Warranty. Contact your DSM in this situation before replacing the light.)
- Cracked lens and/or housing.
- Poor installation of respiration tube at ventilation hole.

**Examples of Light Units With Condensation/Fog That Should Be Replaced**

Heavy/large amount of condensation/fog on the lens is not normal.

- If the condensation/fog clears, it is normal, and the light unit should not be replaced.
- If the condensation/fog does not clear, it is abnormal (water entry is suspected), and the light unit should be replaced.
