Subject: POOR AUXILIARY (AUX) JACK SOUND	Bulletin No: 09-030/10
	Last Issued: 06/23/2010

2010 RX-8 with accessory satellite radio (NOT factory installed)

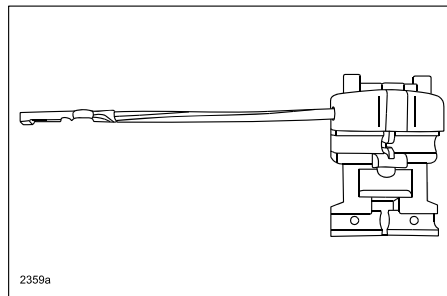
70 mm terminal ended wire with IDC

Some vehicles with the accessory satellite radio might experience poor sound from the auxiliary jack. This is caused by a poor ground. To fix the problem, a signal ground wire will be added to an unpopulated cavity, providing a ground path for the accessory harness. This will be done using a 70 mm terminal ended wire placed into terminal 2G of connector 0920-201 (Audio Unit/Audio Unit Illumination), and connected to either LG/W ground wire (terminal 2F or 2D) of the same connector with an IDC.
