Subject: CERTAIN SATELLITE RADIO STATION PRESETS MAY BE ERASED AND CANNOT BE RESET	Bulletin No: 09-009/09
	Last Issued: 07/24/2009

BULLETIN NOTE

- This bulletin supersedes the previous bulletin issued on 02/16/09. The REPAIR PROCEDURE has been revised.
- Changes are noted below in Red beside the change bar.

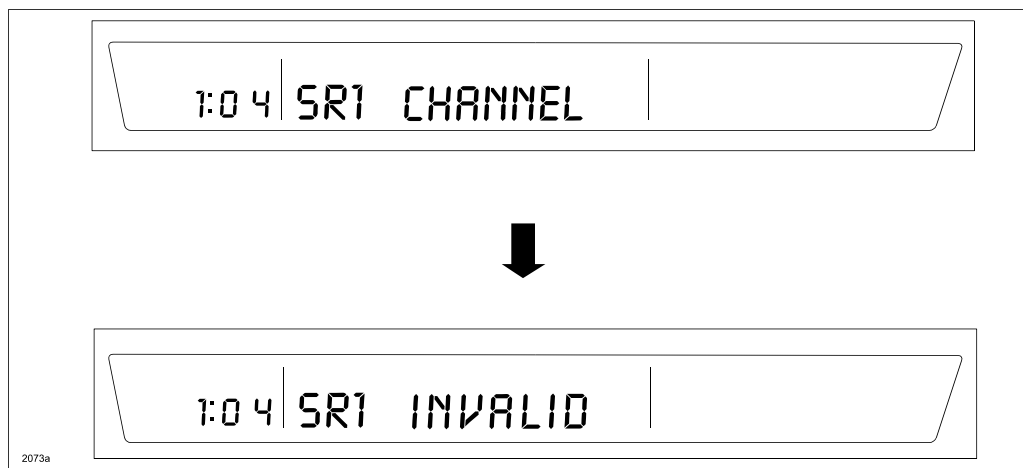
Some customers may experience that their radio station presets of certain satellite radio stations may be erased and cannot be reset. This happens after the Sirius receiver has completed receiving a new firmware version automatically from the Sirius satellite (over-the-air firmware update) or if the Sirius receiver is turned off while the channel map is being updated. When the customer goes to press a preset button, "INVALID" will be displayed as shown in the information display. The problem is an inappropriate design in the audio unit software which has now been changed.

Customers having this concern should have their vehicle's audio unit reprogrammed to the latest version using the following repair procedure and an Audio Unit Software Programming Tool (P/N 1479-06-99).
