<b>Subject:</b>  STAINS FOUND ON PAINT DURING PDI	<b>Bulletin No:</b> 09-036/09
	<b>Last Issued:</b> 11/12/2009

## BULLETIN NOTE

2009-2010 MX-5  
2009-2010 RX-8  
2009-2010 MAZDA3  
2009-2010 MAZDA5  
2009-2010 MAZDA6  
2009-2010 CX-7  
2009-2010 CX-9

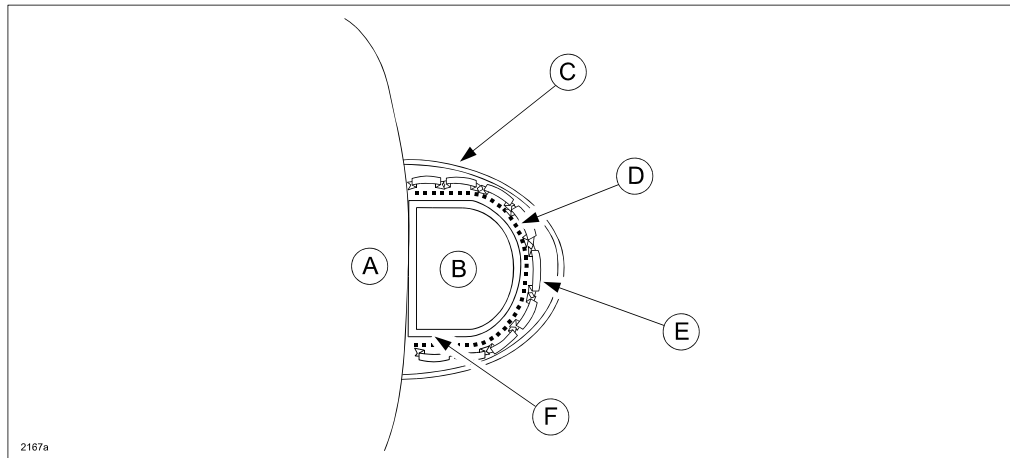
Some vehicles may experience stains appearing on the hood, roof and/or trunk of the vehicle. This concern is most likely to be found in a cold weather areas just after the RAPGARD is removed at PDI. This may be caused by moisture which has been trapped and condensed between the paint and the RAPGARD. These types of stains can be removed with a heat gun or an infrared drier.

1. Visually inspect the top coat surface for stains.
  - If stains are found, use a heat gun (for smaller stains) or an infrared drier (for larger stains) to heat the affected area and remove the stains.
2. Insulate all plastic and rubber parts (as shown below) using heat insulation materials (C ~ F) prior to beginning the application of heat.

- A - Body Panel
- B - Molding
- C - Aluminum foil covering all area
- D - Wet towel
- E - Folded aluminum foil
- F - Aluminum foil tape

- Since this repair procedure requires the use of heat from a heat gun or infrared drier, be sure to insulate all rubber or plastic parts which are easily affected by heat from near the affected stain area.
- Use extreme care to ensure the top coat surface temperature stays below 284°F (140°C).
- To protect materials inside the cabin area (i.e. carpet, seats, etc.), also place insulation over the glass as necessary.
