© 2009 Mazda Motor of America, Inc.

Subject: CHATTERING NOISE / UNABLE TO ADJUST DRIVER-SIDE MANUAL SEAT LIFT	Bulletin No: 09-059/09
	Last Issued: 10/23/2009

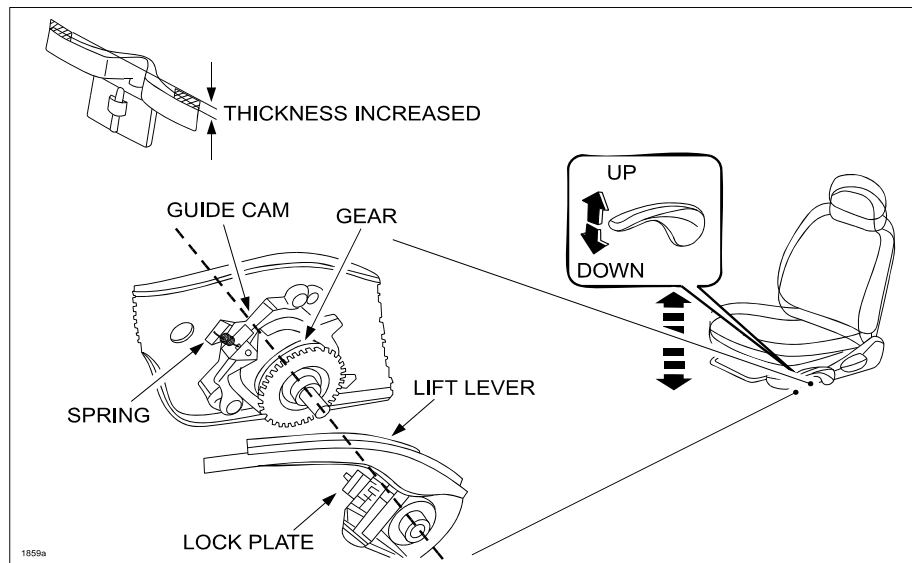
Some vehicles may exhibit a chattering noise and the driver-side seat lift cannot be adjusted because the lock plate guide comes off the guide cam when operating the lift. If the lift lever is then operated with the lock plate guide off, the guide cam can be damaged. The shape of both ends of the guide cam has now been changed to stop the lock plate guide from coming off.

Customers having this concern should have their vehicle repaired using the following repair procedure.

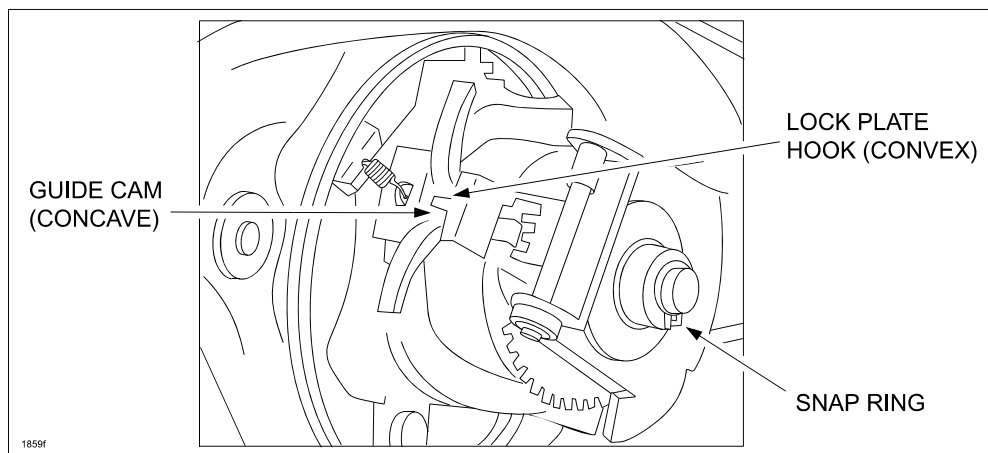
NOTE: If the hook and guide cam are not fitted properly and the lift is operated, the guide cam will be damaged.

- c. Release finger from the moving part of the lock plate, then flip down the hook and allow it to engage with the gear.
- d. Make sure that the hook (convex) of the lock plate is fitted into the guide cam (concave).
