Service Bulletin Mazda North American Operations

Subject: **Bulletin No:** 09-062/09 **SQUEAKING NOISE FROM LEATHER SEATS** Last Issued: 10/23/2009

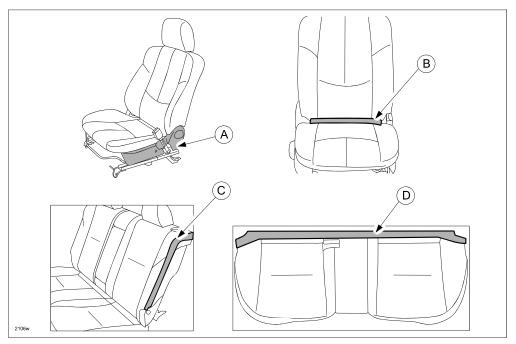
Some vehicles may exhibit a squeaking noise coming from the leather seats. This noise may be caused by the leather seat surfaces contacting each other.

- 1. Verify customer complaint.
- 2. Apply masking tape around surface areas A, B, C & D where silicone grease will be applied.
 - Area A Center console and cushion contact each other (front seat).
 - Area B Cushion and seatback contact each other (front seat).
 - Area C Seatback and trunk contact each other (rear seat).
 - Area D Cushion and seatback contact each other (rear seat).

- 3. Apply silicone grease to areas (A, B, C & D), spraying over each area 2 ~3 times.
- 4. Using a heat gun, apply heat to silicone until silicone is no longer sticky to the touch.

CAUTION: DO NOT allow the heat gun to get too close to the surface of the seat. Too much heat may discolor the seat surface.
