Subject: SQUEAKING NOISE FROM SEAT BACK DUE TO FRAME AND SEAT BACK PAD CONTACT	Bulletin No: 09-069/09
	Last Issued: 11/12/2009

- 2006-2010 MX-5
- 2004-2010 RX-8
- 2004-2010 MAZDA3
- 2006-2010 MAZDA5
- 2003-2010 MAZDA6
- 2007-2010 CX-7
- 2007-2010 CX-9

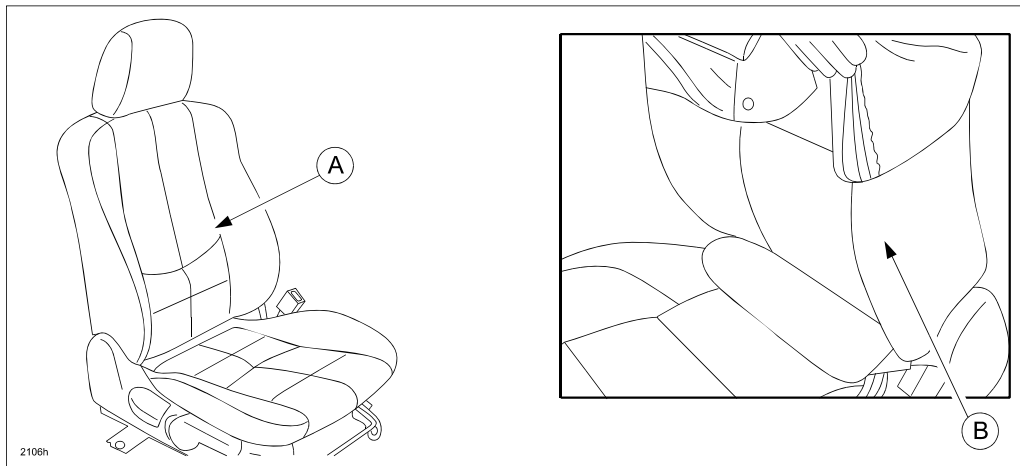
Some vehicles may exhibit a squeaking noise coming from the front seats (A). This noise may be caused by contact between the seat frame and the urethane seat back pad (B).
