<b>Subject:</b> <b>SQUEAKING NOISE FROM UNDER DRIVER SEAT LIFTER LINK</b>	<b>Bulletin No:</b> 09-065/09
	<b>Last Issued:</b> 10/27/2009

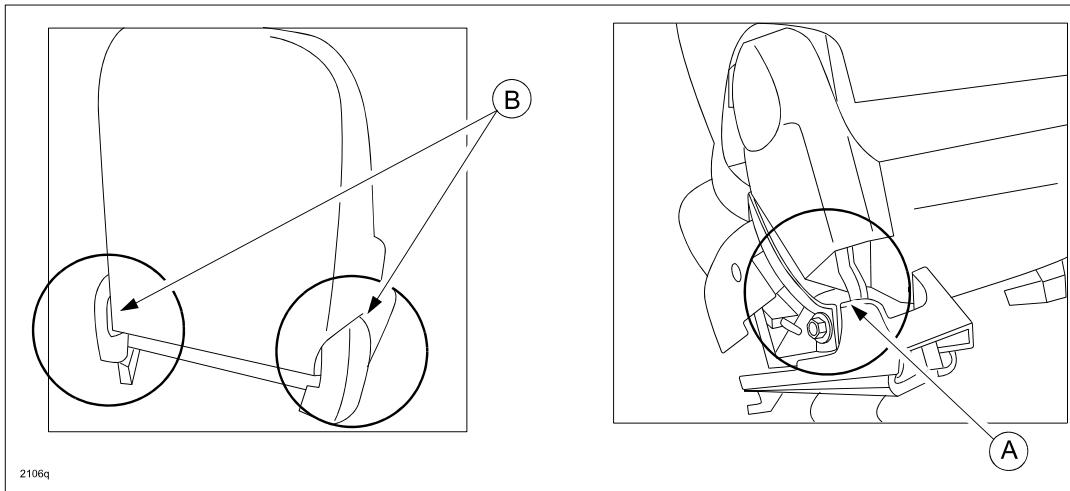
Some vehicles may exhibit a squeaking noise coming from under the driver seat when entering, exiting the vehicle or while driving the vehicle around a corner.

1. Verify customer complaint.
2. Position the seat lifter to highest position.
3. Remove the seat assembly according to the appropriate MS3 online instructions or Workshop Manual.
4. Place the seat on its side on a clean surface.
5. Apply Molybdenum spray grease (B) between the shaft (A) and side frame (C).
