Subject: AUXILIARY PORT VALVE (APV) REMOVAL CAUTION	Bulletin No: 01-034/11
	Last Issued: 10/19/2011

2004-2008 Mazda RX-8 with High Power

2009-2011 Mazda RX-8

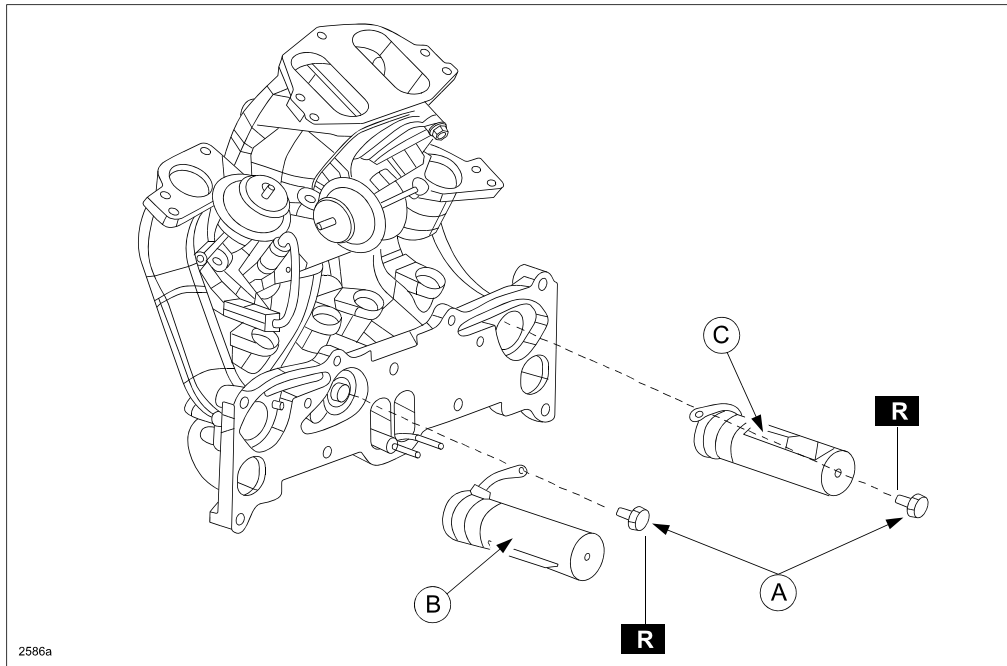
- If the APV is damaged during removal, remove the APV bolts (A), then remove the front APV (B) and/or the rear APV (C) from the inlet manifold and replace with a new one.

APV bolt tightening torque: 0.9-1.2 Nm (9.2-12.0 kgf-cm, 8-10 in-lbf)
