# Service Information

| Category<br><b>T</b> | <b>Repair Guidance</b> | Ref. No.<br>R022/10 | Page<br>1 of 5 |
| Applicable Model<br>Mazda2 (DE), Mazda3 (BL), Mazda5 (CR),<br>Mazda6 (GH), CX-7 (ER), CX-9 (TB), MX-5 (NC),<br>RX-8 (FE/SE) | | Applicable Countries or Specifications<br><br>Worldwide (Except North America) | |

## Subject: Unable to Remove Aftermarket Accessories from Accessory Socket

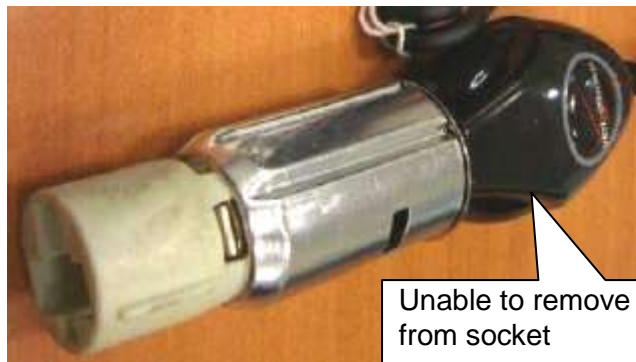
Accessory socket

Some customers may complain that the aftermarket accessories connected to vehicle's accessory socket cannot be removed.

Some aftermarket accessories stuck to the groove inside the accessory socket.

The groove inside the socket has been eliminated.
