# Service Information

Category <b>N</b>	<b>Repair Guidance</b>	Ref. No. R021/09	Page 1 of 2
Coverage <input type="checkbox"/> Distributor only <input checked="" type="checkbox"/> Please inform your dealers		Date Issued March 13 <sup>th</sup> , 2009	
Please convey this information to your <input type="checkbox"/> Director <input checked="" type="checkbox"/> General Manager <input checked="" type="checkbox"/> Warranty Dept. <input checked="" type="checkbox"/> Parts Dept. <input checked="" type="checkbox"/> Training Dept. <input checked="" type="checkbox"/> Field Rep.		Date Revised	
Applicable Model  RX-8 (FE/SE)		Applicable Countries or Specifications  Worldwide

## Subject: Chattering Noise from Steering Wheel When Driving on a Rough Road

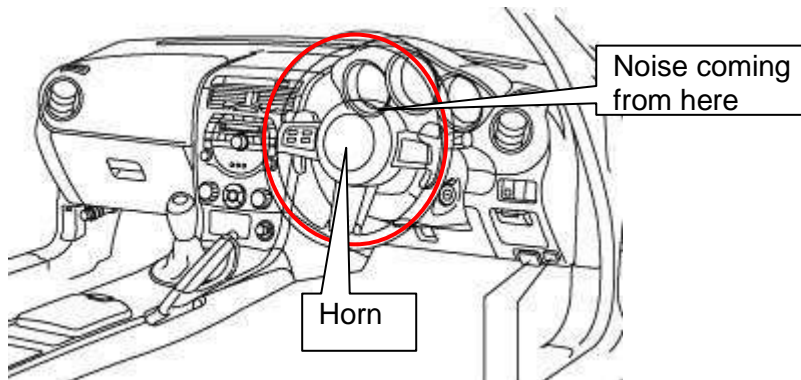
Some customers may express concern of chattering noise from steering wheel when driving rough road. The noise disappears by putting hand on the horn pad.

Steering wheel core cover and rib of airbag module contact each other while driving.
