Service Information

Category E	Technical	Ref. No. E024/06	Page 1 of 2
Coverage <input type="checkbox"/> Distributor only <input checked="" type="checkbox"/> Please inform your dealers		Date Issued September 28, 2006	
Please convey this information to your <input type="checkbox"/> Director <input checked="" type="checkbox"/> General Manager <input checked="" type="checkbox"/> Warranty Dept. <input checked="" type="checkbox"/> Parts Dept. <input checked="" type="checkbox"/> Training Dept. <input checked="" type="checkbox"/> Field Rep.		Date Revised November 6, 2008	
Applicable Models All MC Production Models		Applicable Countries or Specifications Worldwide

Subject: Caution for Coolant

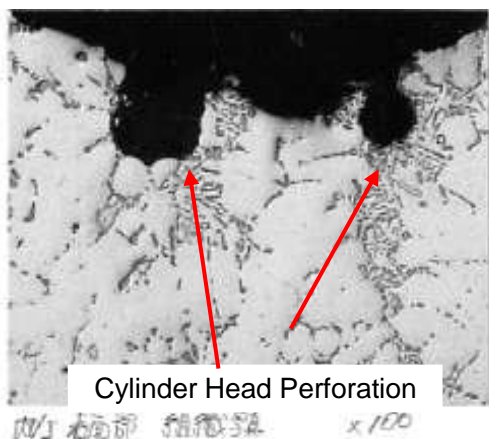
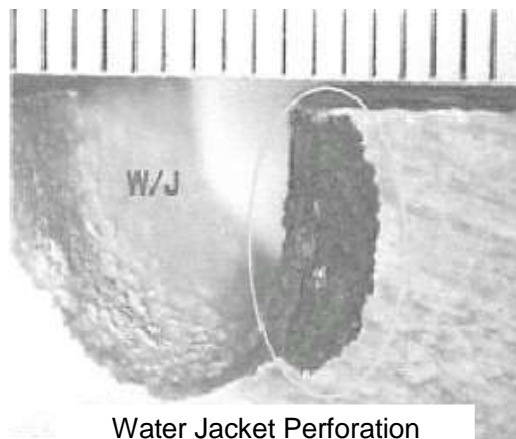
Action / Effect	Possible damage
Borate	<ul style="list-style-type: none"> * Effective for rust prevention of ferrous metal. * May cause aluminum corrosion through the formation of high alkaline compounds (pH 9-11). * In some cases, may damage anticorrosive coating and corrode aluminum parts. * May directly corrode aluminum parts. 	<ul style="list-style-type: none"> * Cylinder head perforation * Water pump body perforation * Aluminum radiator perforation * Heater core perforation
Silicate	<ul style="list-style-type: none"> * Effective for rust prevention of aluminum, but tends to gel (crystallized at a high temperature becoming sediment) and to become vitrified solid because of the instability 	<ul style="list-style-type: none"> * Water pump mechanical seal wear * Vitrified solid caught between seals causes damage to the seals.

This is the affect on the material due to poor coolant.

Please advise your dealers and customers not to use any coolant containing borate or silicate.

Recommended Mazda genuine coolant

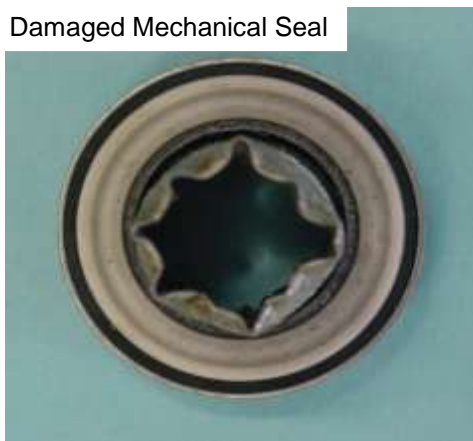
Damaged Mechanical Seal

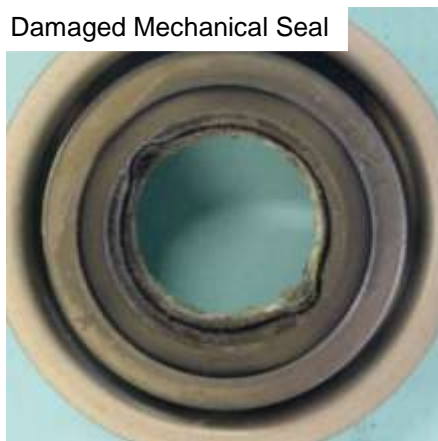
Damaged Mechanical Seal
