Service Information

Category S	Repair Guidance	Ref. No. R018/10	Page 1 of 3
Coverage <input type="checkbox"/> Distributor only <input checked="" type="checkbox"/> Please inform your dealers		Date Issued February 19, 2010	
Please convey this information to your <input type="checkbox"/> Director <input checked="" type="checkbox"/> General Manager <input checked="" type="checkbox"/> Warranty Dept. <input checked="" type="checkbox"/> Parts Dept. <input checked="" type="checkbox"/> Training Dept. <input checked="" type="checkbox"/> Field Rep.		Date Revised	
Applicable Model RX-8 (FE/SE) with cloth-trimmed seat & manual seat lifter		Applicable Countries or Specifications Worldwide

Subject: Driver's Seat Cushion Inclines Forward when Sitting In

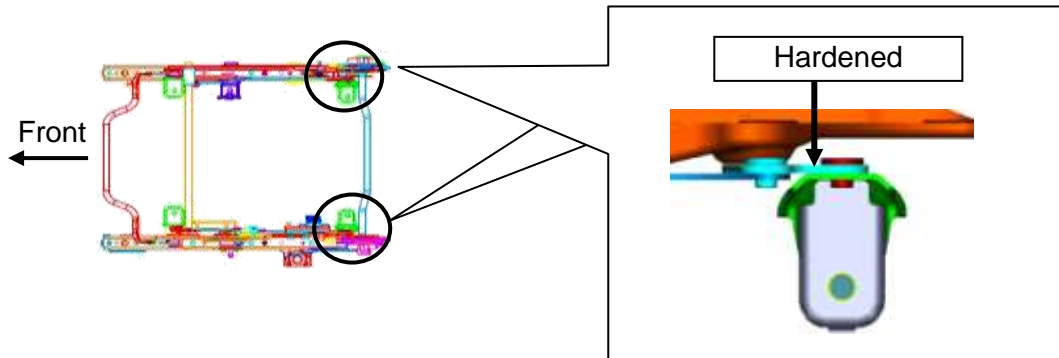
Inadequate mechanical strength of seat adjuster unit rear link.

To increase the strength, seat adjuster unit rear link has been hardened.
