Category F	Technical	Ref. No. E031/05	Page 1 of 1
Coverage <input type="checkbox"/> Distributor only <input checked="" type="checkbox"/> Please inform your dealers		Date Issued November 3, 2005	
Please convey this information to your <input type="checkbox"/> Director <input checked="" type="checkbox"/> General Manager <input checked="" type="checkbox"/> Warranty Dept. <input checked="" type="checkbox"/> Parts Dept. <input checked="" type="checkbox"/> Training Dept. <input checked="" type="checkbox"/> Field Rep.		Date Revised	
Applicable Models RX-8 (FE / SE)		Applicable Countries or Specifications US, EC and ADR Spec.

Subject: DTC P0336 During Engine Start – Service Tip

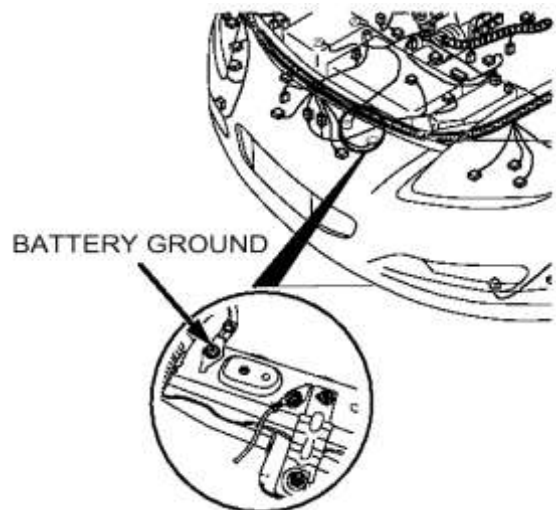
Some customers may complain of an illuminated check engine light after attempting to start the engine. DTC P0336 (Eccentric shaft position sensor range/performance) may be set in PCM memory.

- Loose/poor battery ground located on the front core support
- Low or dead battery causing low output from Eccentric Shaft Position sensor
- Damaged or out of calibration Eccentric Shaft Position sensor.

1. Verify customer concern.
2. Remove engine cover and battery box cover.
3. Locate battery ground wire attachment point to core support. Battery ground is located between battery box and air cleaner box (Black with red tracer, held to body with 10MM bolt).
4. Clean/tighten battery ground contact to body.
5. Verify repair.
