## **Service Information**

Category <b>T</b>	Technical		Ref. No. E028/08	Page 1 of 1
Coverage ☐ Distributor only ■ Please inform your dealers			Date Issued September 16, 2008	
Please convey this information to Warranty Dept. Parts De	l Manager Rep.	Date Revised November 13, 2008		
Applicable Model		Applicable Countries or Specifications		
All Models		Worldwide

## Subject: Crack on Front Fog Lamp Lenses (Warranty Information)

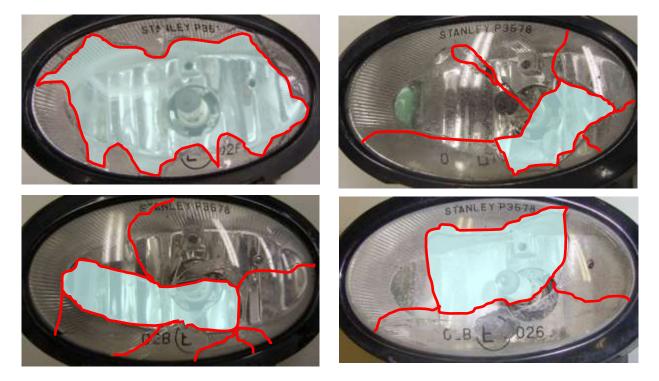
The type of crack and breakage that are equivalent to the following samples are considered as "external factor" and due to stone chipping. These are **not** covered under warranty.

(a) Part of the lens is broken

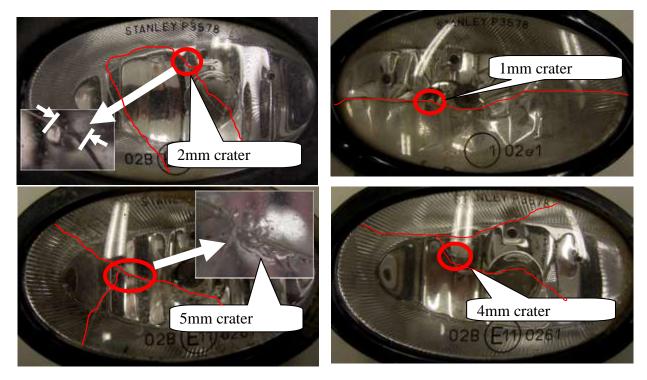
(b) There is a stone chip trace bigger than 1mm diameter on the crack line(s). Feel the trace by using the tip of a pen or a steel measure.
