# Service Information

Category <b>C</b>	<b>Repair Guidance</b>	Ref. No. R046/05 <b>C</b>	Page 1 of 3
Coverage <input type="checkbox"/> Distributor only <input checked="" type="checkbox"/> Please inform your dealers		Date Issued November 24, 2005	
Please convey this information to your <input checked="" type="checkbox"/> Warranty Dept. <input checked="" type="checkbox"/> Parts Dept. <input checked="" type="checkbox"/> Training Dept. <input type="checkbox"/> Director <input checked="" type="checkbox"/> General Manager <input type="checkbox"/> Field Rep.		Date Revised May 28, 2010	
Applicable Models  RX-8 (FE / SE)	Applicable Countries or Specifications  US, EC and ADR Spec.

## Subject: Hesitation and Idle Vibration Due to Cracks on Engine Mount

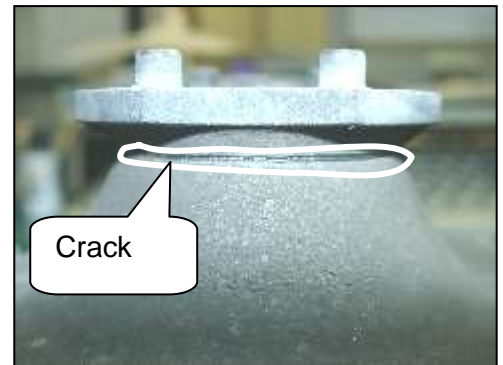
Some vehicles experience a crack appears on the RH side engine mount. As a result, the following symptoms may be observed.

Depending on a driving condition or engine condition, the RH side engine mount rubber may get deformed and wrinkled. As a result, the crack is caused starting from the wrinkles.

When you encounter a customer complaint on this concern, replace both right and left engine mount rubbers with modified ones.
