Service Information

Category T	Repair Guidance	Ref. No. R072/08	Page 1 of 4
Coverage <input type="checkbox"/> Distributor only <input checked="" type="checkbox"/> Please inform your dealers		Date Issued September 4, 2008	
Please convey this information to your <input type="checkbox"/> Director <input checked="" type="checkbox"/> General Manager <input checked="" type="checkbox"/> Warranty Dept. <input checked="" type="checkbox"/> Parts Dept. <input checked="" type="checkbox"/> Training Dept. <input checked="" type="checkbox"/> Field Rep.		Date Revised	
Applicable Model Mazda3 (BK), Mazda6 (GG/GY), RX-8 (FE/SE) and BT-50 (UN) with Retractable Keyless Entry System		Applicable Countries or Specifications Worldwide (except China)

Subject: Key Comes Off From Transmitter

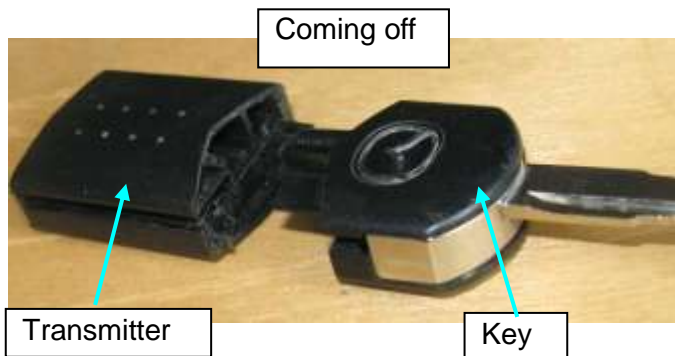
Some customers may complain that the key comes off from the transmitter.

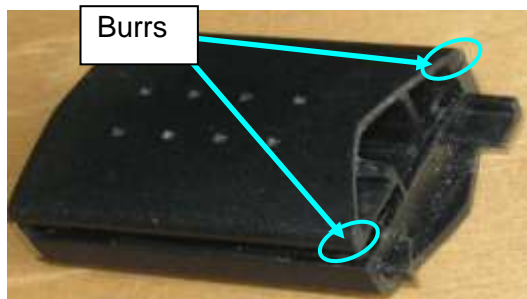
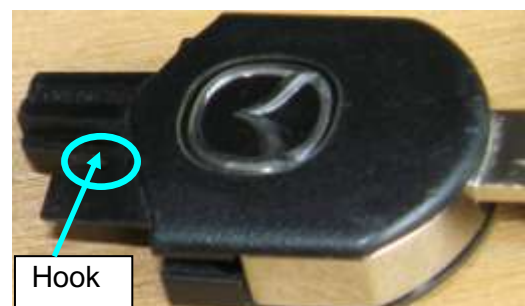
There are burrs on the both corners of the transmitter (back side). Due to them, the key cannot hook on the transmitter strong enough.

The mold tool for transmitter has been modified to prevent the burrs.
