# Service Information

Category <b>S</b>	<b>Repair Guidance</b>	Ref. No. R056/08	Page 1 of 3
Coverage <input type="checkbox"/> Distributor only <input checked="" type="checkbox"/> Please inform your dealers		Date Issued June 26, 2008	
Please convey this information to your <input type="checkbox"/> Director <input checked="" type="checkbox"/> General Manager <input checked="" type="checkbox"/> Warranty Dept. <input checked="" type="checkbox"/> Parts Dept. <input checked="" type="checkbox"/> Training Dept. <input checked="" type="checkbox"/> Field Rep.		Date Revised	
Applicable Model  RX-8 (FE/SE)		Applicable Countries or Specifications  Worldwide

## Subject: Knocking Noise from Rear Door Glass While Driving on Rough Road

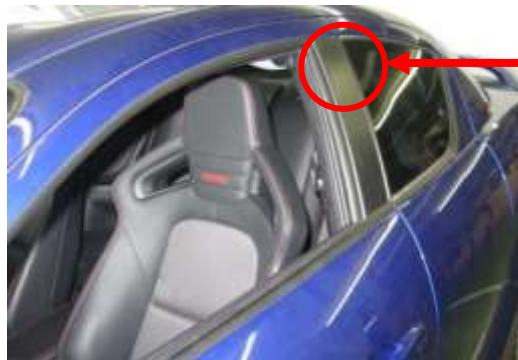
Some vehicles may exhibit a knocking noise from the rear door glass when running on a rough road.

Knocking Noise is coming from here.

Door glass shakes while the vehicle is running on a rough road, which allows it to make contact with the vehicle body.

When you encounter a customer complaint on this concern, attach non-woven fabric to between the door glass and the vehicle body as per the following procedure.
