# Service Information

Category <b>S</b>	<b>Repair Guidance</b>	Ref. No. R038/08	Page 1 of 2
Coverage <input type="checkbox"/> Distributor only <input checked="" type="checkbox"/> Please inform your dealers		Date Issued April 24, 2008	
Please convey this information to your <input type="checkbox"/> Director <input checked="" type="checkbox"/> General Manager <input checked="" type="checkbox"/> Warranty Dept. <input checked="" type="checkbox"/> Parts Dept. <input checked="" type="checkbox"/> Training Dept. <input checked="" type="checkbox"/> Field Rep.		Date Revised October 23, 2008	
Applicable Model  RX-8 (FE/SE)		Applicable Countries or Specifications  Worldwide

## Subject: Unusual Noise from Front of Vehicle / Front Stabilizer Control Link Breakage

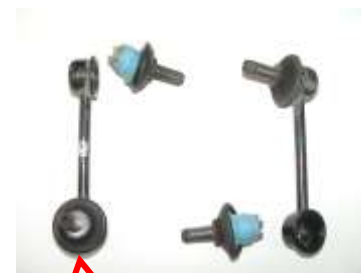
Some vehicles may exhibit an unusual noise from the front side of the vehicle.

The plastic part connecting the stabilizer control link ball joint to the link is broken apart. As a result, the front lower arm and stabilizer bar are not connected.

When you encounter a customer complaint on this concern, replace the front control links with service ones.

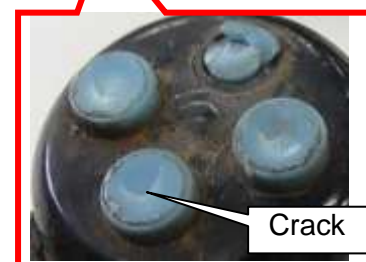
Due to excessive impact, the swaying friction of the ball joint increases momentarily and the ball seat receives the load. After this has been repeated some times, a fatigue breakage is caused on the caulking part of the ball joint.

The front control link has been changed to the low friction type.
