Service Information

Subject: Caution for Shock Absorber Replacement

Update Note: This information supersedes the previous E004/03. Judgment Criteria has been revised.

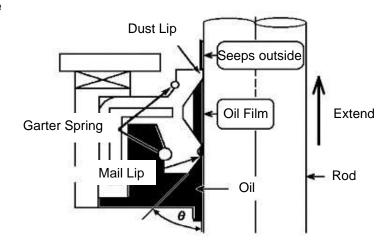
Cause of Oil Seepage

Oil seepage is caused by the following factors and not a problem.

- 1. The small amount of oil seeps outside through the dust lip at the normal operation.
- 2. The oil film thickness is uneven due to production variation of rod and seal.

When the rod receives input from the road then extends upward, most of the oil on the rod is scraped off by the main lip and some remains inside the dust lip.

When the rod extends further, then most of the remaining oil on the rod is scraped off by the dust lip and small amount of oil seeps outside.
