Subject: TPMS WARNING LIGHT ON	Bulletin No: 02-001/12
	Last Issued: 01/11/2012

APPLICABLE MODEL(S)/VINS

Vehicles produced between March 1, 2007 and May 25, 2010

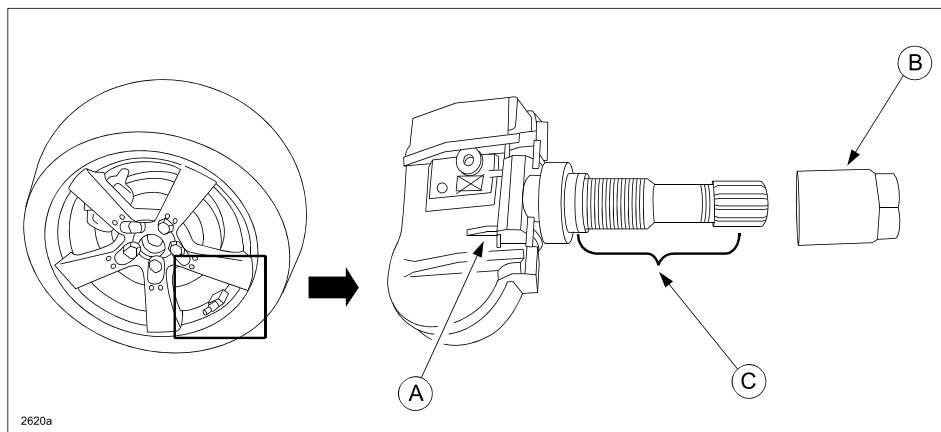
1. Verify customer concern.
2. Check if any of the valve stems (C) have neck breakage/hairline crack or the valve nuts (B) have breakage.
 - If any have breakage or cracks, go to step 3.
 - If they DO NOT have breakage or cracks, troubleshoot the TPMS using MS3 online instructions or Workshop Manual section 02.

Wheel Unit Set = Wheel Unit (A) and Valve Nut (B).

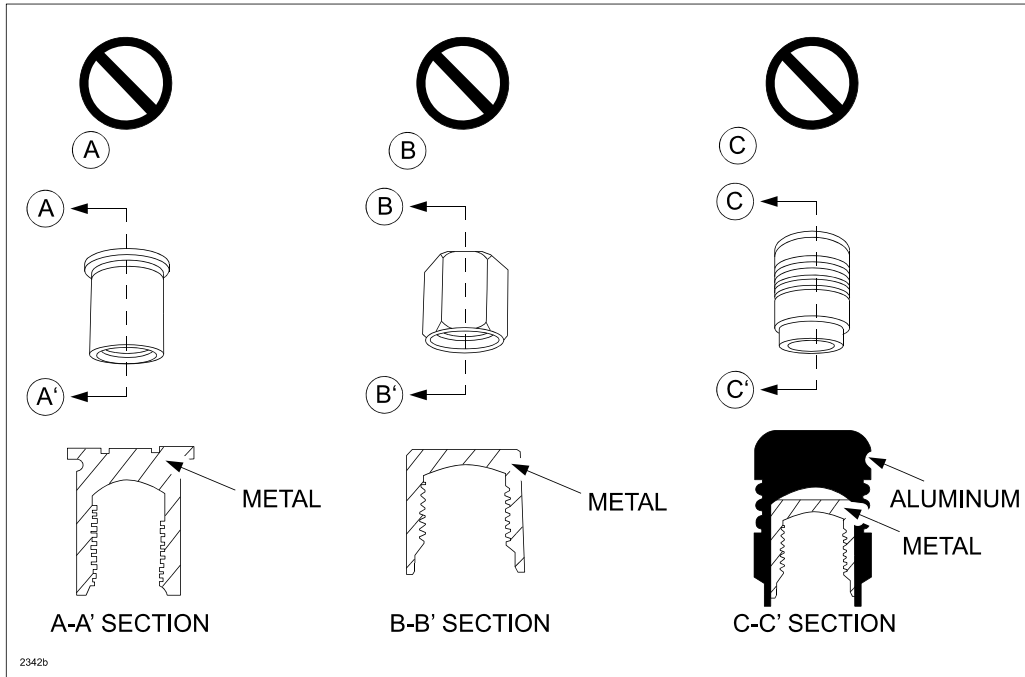
Examples of Aftermarket valve cap

3. Verify that all the valve caps are Mazda genuine or all plastic.
- If they are Mazda genuine or all plastic, go to step 4.
 - If they are NOT Mazda genuine and are NOT all plastic (and are aftermarket valve caps with metal), replace them with Mazda genuine ones (all plastic) at customer's expense and go to step 4. Explain to the customer that some aftermarket valve stem caps are made of metal or have thread inserts that are made of metal. When metal and aluminum are together in such a condition, galvanic corrosion occurs between the aluminum valve stem of the TPMS sensor unit and the metal threads of the valve stem cap. This corrosion can cause them to fuse together, becoming difficult to remove by hand. When more force is used to remove the valve stem cap, the aluminum valve stem of the TPMS sensor unit will break off and the TPMS sensor unit will need to be replaced.

NOTE: Damage to TPMS sensor units by installing aftermarket valve stem caps made of metal or with metal inserts is NOT covered by Mazda Warranty and claims where the sensor is found damaged in this manner will be denied or debited to the repairing dealer.

(A): Metal; (B): Chrome; (C) Aluminum with metal insert

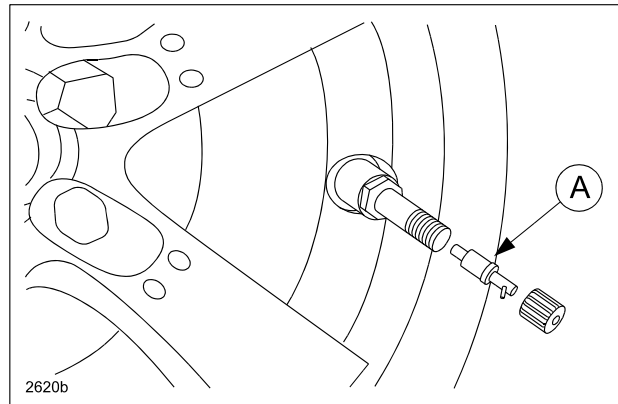
NOTE: Excessive force applied on the wheel unit is the main cause of valve stem damage. Refer to TSB 02-003/11 “SERVICE CAUTION FOR TPMS” for proper handling of TPMS. Make sure to use the correct tightening torque when tightening the valve core (A).

Tightening torque: 0.2 - 0.4 Nm (2.1 - 4.0 kgf cm, 1.8 - 3.5 in lbf)

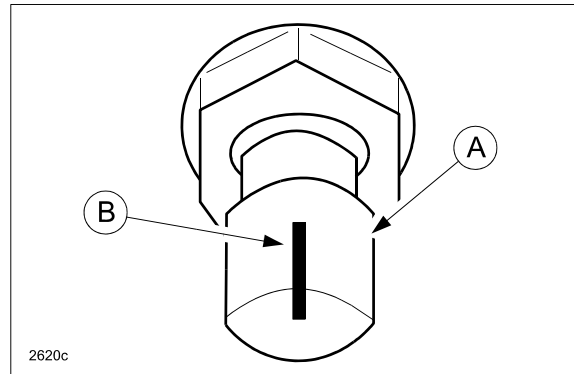
1. Tighten the valve cap (A), then put a mark (B) on the valve cap before loosening it.

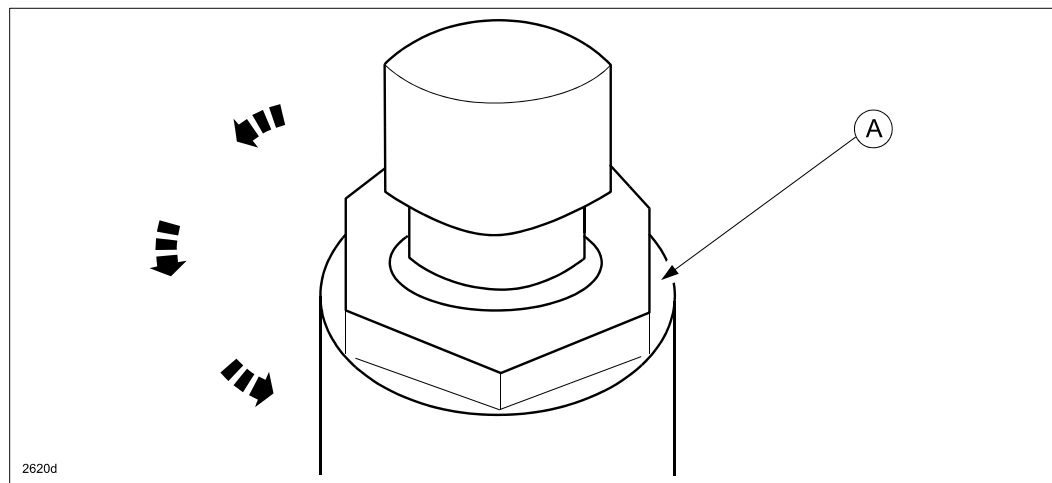
2. Check the corrosion level by checking the valve nut (A) loosening torque. A corroded one will have a higher torque.

NOTE: Tire air pressure should be at specification while checking the torque.

- **Nut is less than 4 Nm (35.4 in-lb):** Replace valve nut with a new one, then go to step 3.

- Check that the valve stem stays in the original position. If the valve stem is rotated approximately more than 30 degrees by torque checking, replace the wheel unit with a new one.
- Be careful not to push the valve too hard after removing the nut, otherwise the wheel unit seal may be dislocated from the wheel. If dislocated, replace the wheel unit with a new one (No warranty).
- **Nut is 4 Nm (35.4 in-lb) or more:** Replace the wheel unit set (wheel unit and valve nut) with new ones. Refer to MS3 online instructions or Workshop Manual section 02-12.

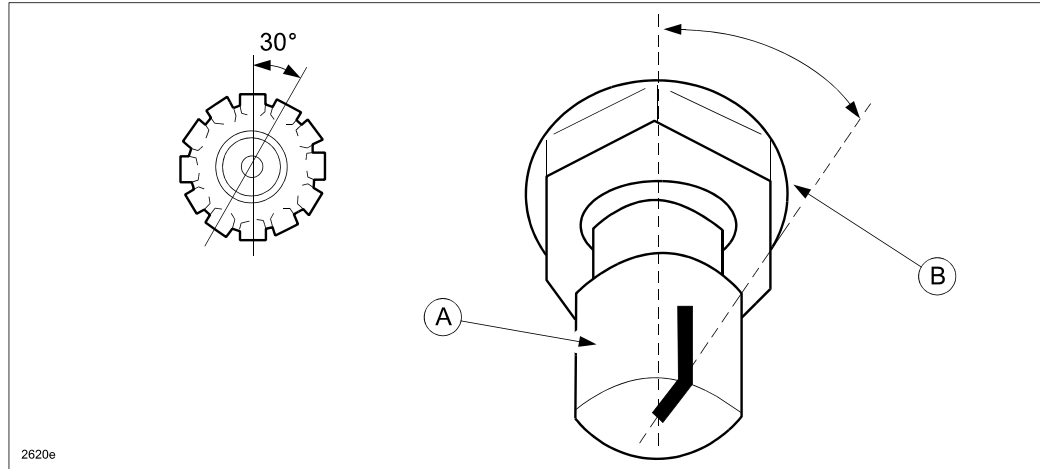
CAUTION: If the marking on the cap (A) turns more than 30 degrees while tightening the valve nut (B), replace the wheel unit with a new one.

3. Install and tighten a new valve nut.

Tightening torque: 7.5 - 8.5 Nm (77 - 86 kgf cm, 67 - 75 in lbf)
