| Subject: STAINS FOUND ON PAINT DURING PDI | Bulletin No: 09-011/12 |
| | Last Issued: 03/12/2012 |

DESCRIPTION

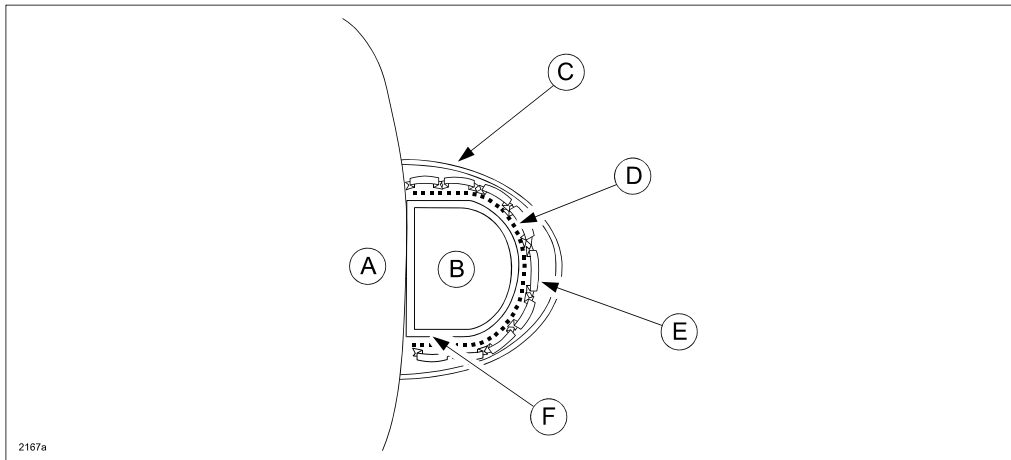
- A - Body Panel
- B - Molding
- C - Aluminum foil covering all area
- D - Wet towel
- E - Folded aluminum foil
- F - Aluminum foil tape

1. Visually inspect the top coat surface for stains.
 - If stains are found, use a heat gun (for smaller stains) or an infrared drier (for larger stains) to heat the affected area and remove the stains.
2. Insulate all plastic and rubber parts (as shown below) using heat insulation materials (C ~ F) prior to beginning the application of heat.

- Since this repair procedure requires the use of heat from a heat gun or infrared drier, be sure to insulate all rubber or plastic parts which are easily affected by heat from near the affected stain area.
- Use extreme care to ensure the top coat surface temperature stays below 284°F (140°C).
- To protect materials inside the cabin area (i.e. carpet, seats, etc.), also place insulation over the glass as necessary.
